## DAMAGE CHART

A/C Reg: T-A321C

Type: A321i

Effective date: 04-Jun-2025 / 07:21 UTC

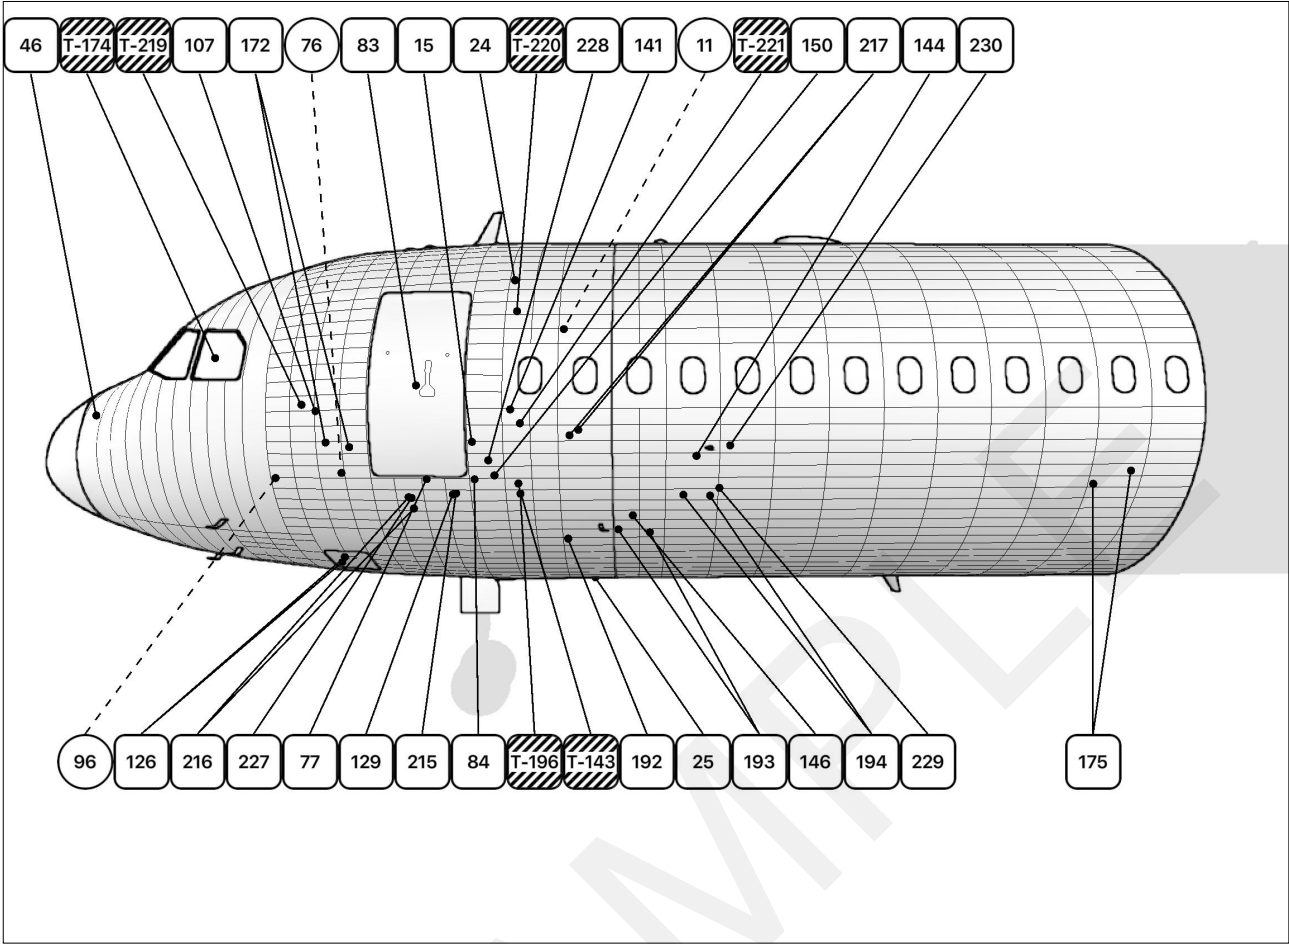
Front LH

| No | Type | Location | Description | Date |
|---|---|---|---|---|
| T-143* | Damage | FR21 + 131.00mm, STRG23LH + 60.00mm | Dent aft of pax door 1 | 09/09/2024 |
| T-174* | Damage | Cockpit Window | Scratch | 19/11/2024 |
| T-196* | Damage | FR21 + 145.00mm, STRG24LH + 49.00mm | Dent near pax door | 09/02/2025 |
| T-219* | Damage | FR13 + 125.00mm, STRG17LH + 88.00mm | Dent near pax door | 08/04/2025 |
| T-220* | Damage | FR21 + 112.00mm, STRG11LH + 123.00mm | Dent on fwd fuse | 08/04/2025 |
| T-221* | Damage | FR21 + 174.00mm, STRG18LH + 145.00mm | Dent near fwd door | 08/04/2025 |
| 11 | Repair | FR23 + 50.00mm, STRG13LH + 10.00mm | Dent on Fuselage - Section 15/21 LH FR23 STRG13 | 08/09/2017 |
| 15 | Damage | FR20 + 50.00mm, STRG20LH + 10.00mm | Dent on Fuselage - Section 15/21 LH FR20 STRG20 | 27/02/2018 |
| 24 | Damage | FR21 + 50.00mm, STRG9LH + 10.00mm | Gouge on Fuselage - Section 15/21 LH FR21 STRG9 | 27/02/2018 |
| 25 | Damage | FR23 + 287.00mm, STRG37LH + 65.00mm | Dent and Gouge on Fuselage - Section 15/21 FR23 STRG37 | 01/04/2018 |
| 46 | Damage | FR1 + 266.00mm, CLLH + 969.00mm | Dent on Fuselage - Section 15/21 FR1 STRG20 | 14/01/2022 |
| 76 | Repair | FR14 + 228.00mm, STRG22LH + 75.00mm | Corrosion on Fuselage - Section 11/12 LH FR14 STRG16 | 18/11/2022 |
| 77 | Damage | FR18 + 50.00mm, STRG23LH + 10.00mm | Corrosion on Fuselage - Section 11/12 LH FR18 STRG23 | 19/11/2022 |
| 83 | Damage | PASSENGER DOOR NO 1 LH | Scratch on PASSENGER DOOR NO 1 LH | 25/11/2022 |

| 84 | Damage | FR20 + 50.00mm, STRG23LH + 10.00mm | Corrosion on Fuselage - Section 11/12 LH FR20 STRG23 | 26/11/2022 |
| 96 | Repair | FR12 + 50.00mm, STRG23LH + 10.00mm | sheared Fateners on Fuselage - Section 11/12 LH FR12 STRG23 | 08/12/2022 |
| 107 | Damage | FR14 + 10.00mm, STRG18LH + 5.00mm | Dent fwd lh door 1 | 11/01/2024 |
| 126 | Damage | Door - Avionics Compartment Lateral Left | ligghtning strike | 17/04/2024 |
| 129 | Damage | FR19 + 64.00mm, STRG24LH + 53.00mm | Dent below pax door | 15/05/2024 |
| 141 | Damage | FR21 + 80.00mm, STRG18LH + 10.00mm | Dent aft pax door | 30/06/2024 |
| 144 | Damage | FR25 + 300.00mm, STRG21LH + 30.00mm | Dent close to aoa sensor | 16/09/2024 |
| 146 | Damage | FR24 + 200.00mm, STRG26LH + 70.00mm | Scratch near sensor on lh side | 17/09/2024 |
| 150 | Damage | FR20 + 250.00mm, STRG22LH + 100.00mm | Dent aft of fwd pax door | 09/10/2024 |
| 172 | Damage | FR14 + 100.00mm, STRG20LH + 10.00mm | 2 dents fwd of pax door | 19/11/2024 |
| 175 | Damage | FR33 + 59.00mm, STRG23LH + 91.00mm | Dents near middle pax door | 02/12/2024 |
| 192 | Damage | FR23 + 50.00mm, STRG29LH + 20.00mm | Dent near aoa probe | 17/12/2024 |
| 193 | Damage | FR24 + 50.00mm, STRG28LH + 10.00mm | Strike near aoa probe | 17/12/2024 |
| 194 | Damage | FR25 + 180.00mm, STRG24LH + 70.00mm | Dents below aoa sensor | 21/01/2025 |
| 215 | Damage | FR19 + 100.00mm, STRG24LH + 40.00mm | Dent below fwd pax door | 04/03/2025 |
| 216 | Damage | FR17 + 120.00mm, STRG24LH + 90.00mm | Dent below fwd pax door | 05/03/2025 |
| 217 | Damage | FR23 + 200.00mm, STRG19LH + 50.00mm | Strike aft of fwd door | 10/03/2025 |
| 227 | Damage | FR17 + 150.00mm, STRG24LH + 100.00mm | Dent below fwd pax door | 15/04/2025 |
| 228 | Damage | FR20 + 200.00mm, STRG21LH + 70.00mm | Dent aft lower fwd pax door | 16/04/2025 |
| 229 | Damage | FR26 + 10.00mm, STRG24LH - 10.00mm | Dent | 12/05/2025 |
| 230 | Damage | FR26 + 100.00mm, STRG20LH + 50.00mm | Dent near aoa sensor | 20/05/2025 |

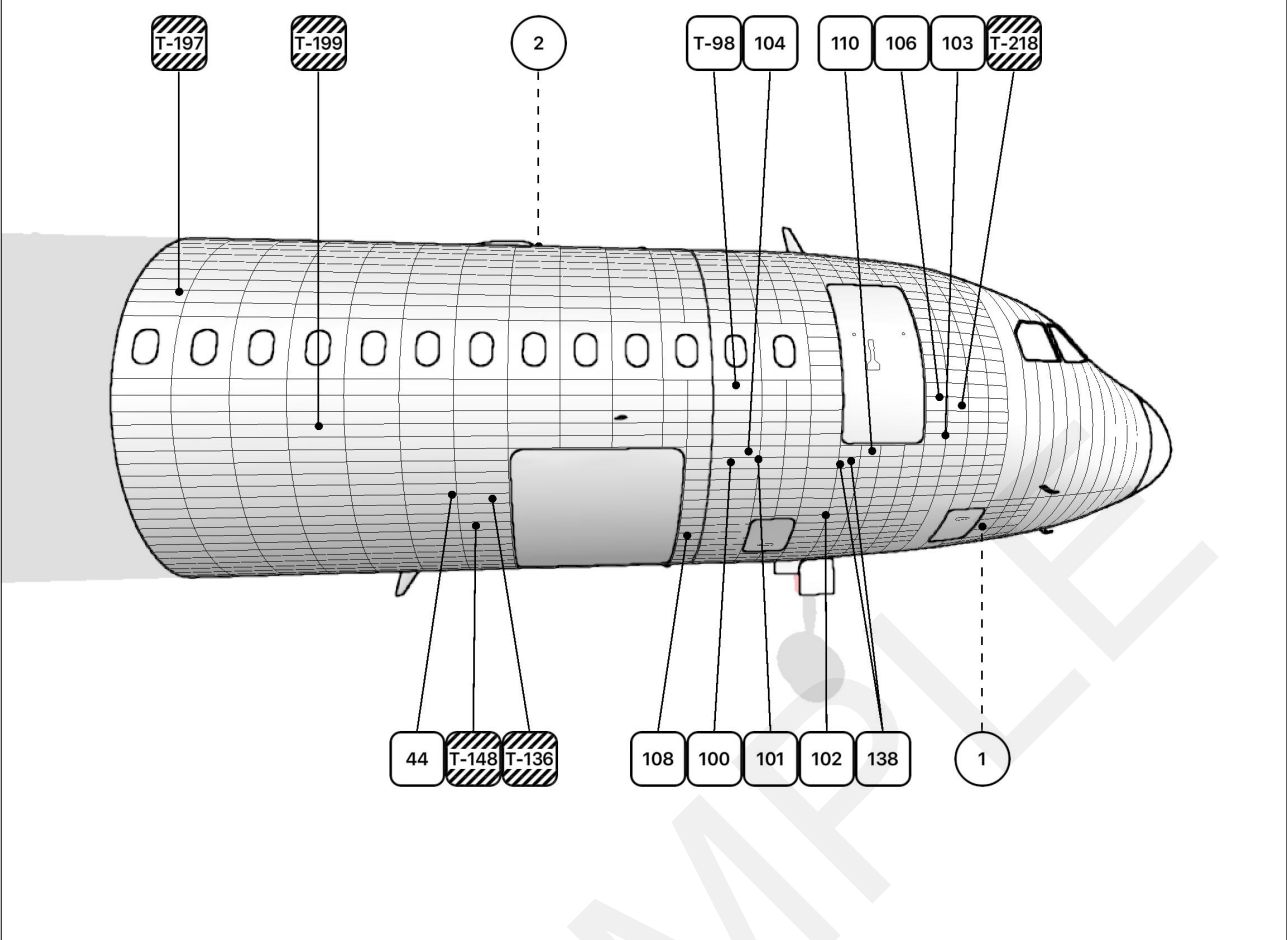
Front RH

| No | Type | Location | Description | Date |
|---|---|---|---|---|
| T-98* | Damage | FR23 + 280.00mm, STRG18RH + 55.00mm | Dent - Fuse Skin, AFT of R1 Door, FWD of Triangle Reference Point, FR 23 -24, S18R-S19R | 26/09/2023 |
| T-136* | Damage | FR28 + 178.00mm, STRG27RH + 69.00mm | Dent | 02/06/2024 |
| T-148* | Damage | FR28 + 373.00mm, STRG30RH + 61.00mm | 2 Dents near CGO door | 08/10/2024 |
| T-199* | Damage | FR31 + 243.00mm, STRG21RH + 20.00mm | Dent | 09/02/2025 |
| 1 | Repair | FR11 + 137.00mm, STRG32RH + 173.00mm | Skin/Fastener Burn on Fuselage - Section 15/21 RH FR10 STRG32 | 09/01/2012 |
| 2 | Repair | FR27 + 269.00mm, STRG2RH + 137.00mm | Skin/Fastener Burn on Fuselage - Section 15/21 RH FR26 STRG33 | 27/04/2015 |
| 44 | Damage | FR29 + 50.00mm, STRG27RH + 10.00mm | Dent on Fuselage - Section 15/21 RH FR29 STRG27 | 20/11/2021 |
| 100 | Damage | FR23 + 311.00mm, STRG24RH + 52.00mm | Dent fwd of cargo | 25/10/2023 |
| 101 | Damage | FR23 + 10.00mm, STRG24RH + 20.00mm | Dent fwd of cargo door | 25/10/2023 |
| 102 | Damage | FR20 + 20.00mm, STRG30RH + 10.00mm | Lightning strike fwd of avionics door | 01/11/2023 |
| 103 | Damage | FR15 + 10.00mm, STRG22RH + 20.00mm | Lightning strike fwd of service door | 02/11/2023 |
| 104 | Damage | FR23 + 125.00mm, STRG23RH + 59.00mm | Dent on fuse | 29/11/2023 |
| 106 | Damage | FR15 + 100.00mm, STRG19RH + 5.00mm | Dent fwd of pax door 1 rh | 04/12/2023 |

| 108 | Damage | FR24 + 166.00mm, STRG32RH + 53.00mm | Dent fwd of cargo door | 16/01/2024 | |
| 110 | Damage | FR18 + 98.00mm, STRG23RH + 66.00mm | Dent | 07/02/2024 | |
| 138 | Damage | FR19 + 100.00mm, STRG24RH + 50.00mm | Lightning strike | 05/06/2024 | |

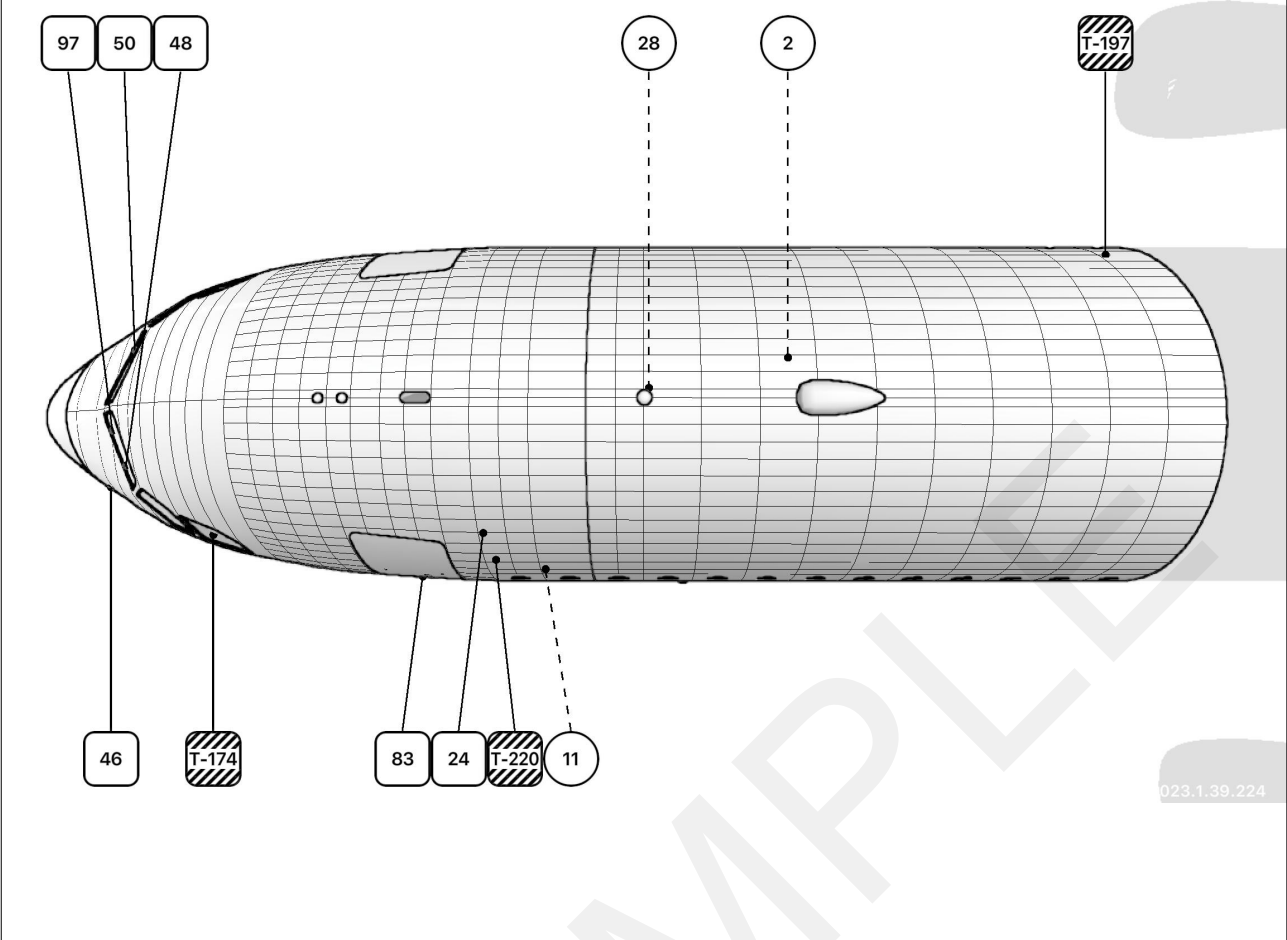
Front Top

| No | Type | Location | Description | Date |
|---|---|---|---|---|
| T-174* | Damage | Cockpit Window | Scratch | 19/11/2024 |
| T-220* | Damage | FR21 + 112.00mm, STRG11LH + 123.00mm | Dent on fwd fuse | 08/04/2025 |
| 2 | Repair | FR27 + 269.00mm, STRG2RH + 137.00mm | Skin/Fastener Burn on Fuselage - Section 15/21 RH FR26 STRG33 | 27/04/2015 |
| 11 | Repair | FR23 + 50.00mm, STRG13LH + 10.00mm | Dent on Fuselage - Section 15/21 LH FR23 STRG13 | 08/09/2017 |
| 24 | Damage | FR21 + 50.00mm, STRG9LH + 10.00mm | Gouge on Fuselage - Section 15/21 LH FR21 STRG9 | 27/02/2018 |
| 28 | Repair | FR25 + 50.00mm, STRG1RH + 10.00mm | Repair on Fuselage - Section 15/21 RH FR25 STRG1 | 28/02/2018 |
| 46 | Damage | FR1 + 266.00mm, CLLH + 969.00mm | Dent on Fuselage - Section 15/21 FR1 STRG20 | 14/01/2022 |
| 48 | Damage | Cockpit Window | Delamination on Cockpit Window | 08/04/2022 |
| 50 | Damage | Cockpit Window | Delamination on Cockpit Window | 08/04/2022 |
| 83 | Damage | PASSENGER DOOR NO 1 LH | Scratch on PASSENGER DOOR NO 1 LH | 25/11/2022 |
| 97 | Damage | Cockpit Window | Scratches - Flight Deck Captain Sliding Window Inner Panel | 26/09/2023 |

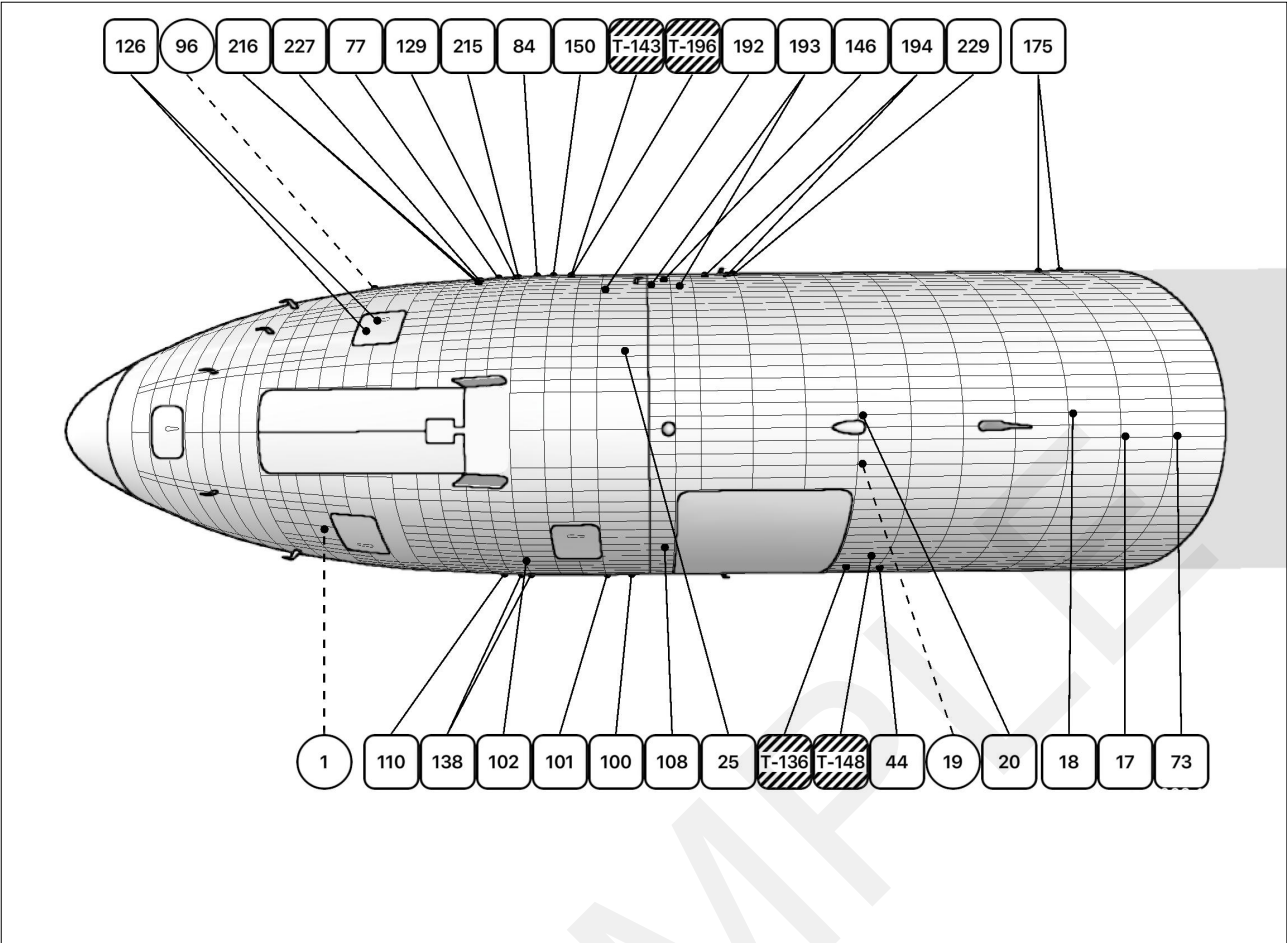
Front Lower

| No | Type | Location | Description | Date |
|---|---|---|---|---|
| T-136* | Damage | FR28 + 178.00mm, STRG27RH + 69.00mm | Dent | 02/06/2024 |
| T-143* | Damage | FR21 + 131.00mm, STRG23LH + 60.00mm | Dent aft of pax door 1 | 09/09/2024 |
| T-148* | Damage | FR28 + 373.00mm, STRG30RH + 61.00mm | 2 Dents near CGO door | 08/10/2024 |
| T-196* | Damage | FR21 + 145.00mm, STRG24LH + 49.00mm | Dent near pax door | 09/02/2025 |
| 1 | Repair | FR11 + 137.00mm, STRG32RH + 173.00mm | Skin/Fastener Burn on Fuselage - Section 15/21 RH FR10 STRG32 | 09/01/2012 |
| 17 | Damage | FR33 + 50.00mm, STRG43RH + 10.00mm | Corrosion on Fuselage - Section 15/21 RH FR33 STRG43 | 27/03/2018 |
| 18 | Damage | FR32 + 50.00mm, STRG43LH + 10.00mm | Corrosion on Fuselage - Section 15/21 LH FR32 STRG43 | 27/03/2018 |
| 19 | Repair | FR28 + 50.00mm, STRG41RH + 10.00mm | Skin/Fastener Burn on Fuselage - Section 15/21 RH FR28 STRG41 | 18/03/2018 |
| 20 | Damage | FR28 + 50.00mm, STRG43LH + 10.00mm | Skin/Fastener Burn on Fuselage - Section 15/21 LH FR28 STRG43 | 27/03/2018 |
| 25 | Damage | FR23 + 287.00mm, STRG37LH + 65.00mm | Dent and Gouge on Fuselage - Section 15/21 FR23 STRG37 | 01/04/2018 |
| 44 | Damage | FR29 + 50.00mm, STRG27RH + 10.00mm | Dent on Fuselage - Section 15/21 RH FR29 STRG27 | 20/11/2021 |
| 73 | Damage | FR34 + 50.00mm, STRG43RH + 10.00mm | Wear Mark on Fuselage - Section 15/21 RH FR34 STRG43 | 15/11/2022 |
| 77 | Damage | FR18 + 50.00mm, STRG23LH + 10.00mm | Corrosion on Fuselage - Section 11/12 LH FR18 STRG23 | 19/11/2022 |
| 84 | Damage | FR20 + 50.00mm, STRG23LH + 10.00mm | Corrosion on Fuselage - Section 11/12 LH FR20 STRG23 | 26/11/2022 |
| 96 | Repair | FR12 + 50.00mm, STRG23LH + 10.00mm | sheared Fateners on Fuselage - Section 11/12 LH FR12 STRG23 | 08/12/2022 |

| 100 | Damage | FR23 + 311.00mm, STRG24RH + 52.00mm | Dent fwd of cargo | 25/10/2023 |
| 101 | Damage | FR23 + 10.00mm, STRG24RH + 20.00mm | Dent fwd of cargo door | 25/10/2023 |
| 102 | Damage | FR20 + 20.00mm, STRG30RH + 10.00mm | Lightning strike fwd of avionics door | 01/11/2023 |
| 108 | Damage | FR24 + 166.00mm, STRG32RH + 53.00mm | Dent fwd of cargo door | 16/01/2024 |
| 110 | Damage | FR18 + 98.00mm, STRG23RH + 66.00mm | Dent | 07/02/2024 |
| 126 | Damage | Door - Avionics Compartment Lateral Left | ligghtning strike | 17/04/2024 |
| 129 | Damage | FR19 + 64.00mm, STRG24LH + 53.00mm | Dent below pax door | 15/05/2024 |
| 138 | Damage | FR19 + 100.00mm, STRG24RH + 50.00mm | Lightning strike | 05/06/2024 |
| 146 | Damage | FR24 + 200.00mm, STRG26LH + 70.00mm | Scratch near sensor on lh side | 17/09/2024 |
| 150 | Damage | FR20 + 250.00mm, STRG22LH + 100.00mm | Dent aft of fwd pax door | 09/10/2024 |
| 175 | Damage | FR33 + 59.00mm, STRG23LH + 91.00mm | Dents near middle pax door | 02/12/2024 |
| 192 | Damage | FR23 + 50.00mm, STRG29LH + 20.00mm | Dent near aoa probe | 17/12/2024 |
| 193 | Damage | FR24 + 50.00mm, STRG28LH + 10.00mm | Strike near aoa probe | 17/12/2024 |
| 194 | Damage | FR25 + 180.00mm, STRG24LH + 70.00mm | Dents below aoa sensor | 21/01/2025 |
| 215 | Damage | FR19 + 100.00mm, STRG24LH + 40.00mm | Dent below fwd pax door | 04/03/2025 |
| 216 | Damage | FR17 + 120.00mm, STRG24LH + 90.00mm | Dent below fwd pax door | 05/03/2025 |
| 227 | Damage | FR17 + 150.00mm, STRG24LH + 100.00mm | Dent below fwd pax door | 15/04/2025 |
| 229 | Damage | FR26 + 10.00mm, STRG24LH - 10.00mm | Dent | 12/05/2025 |

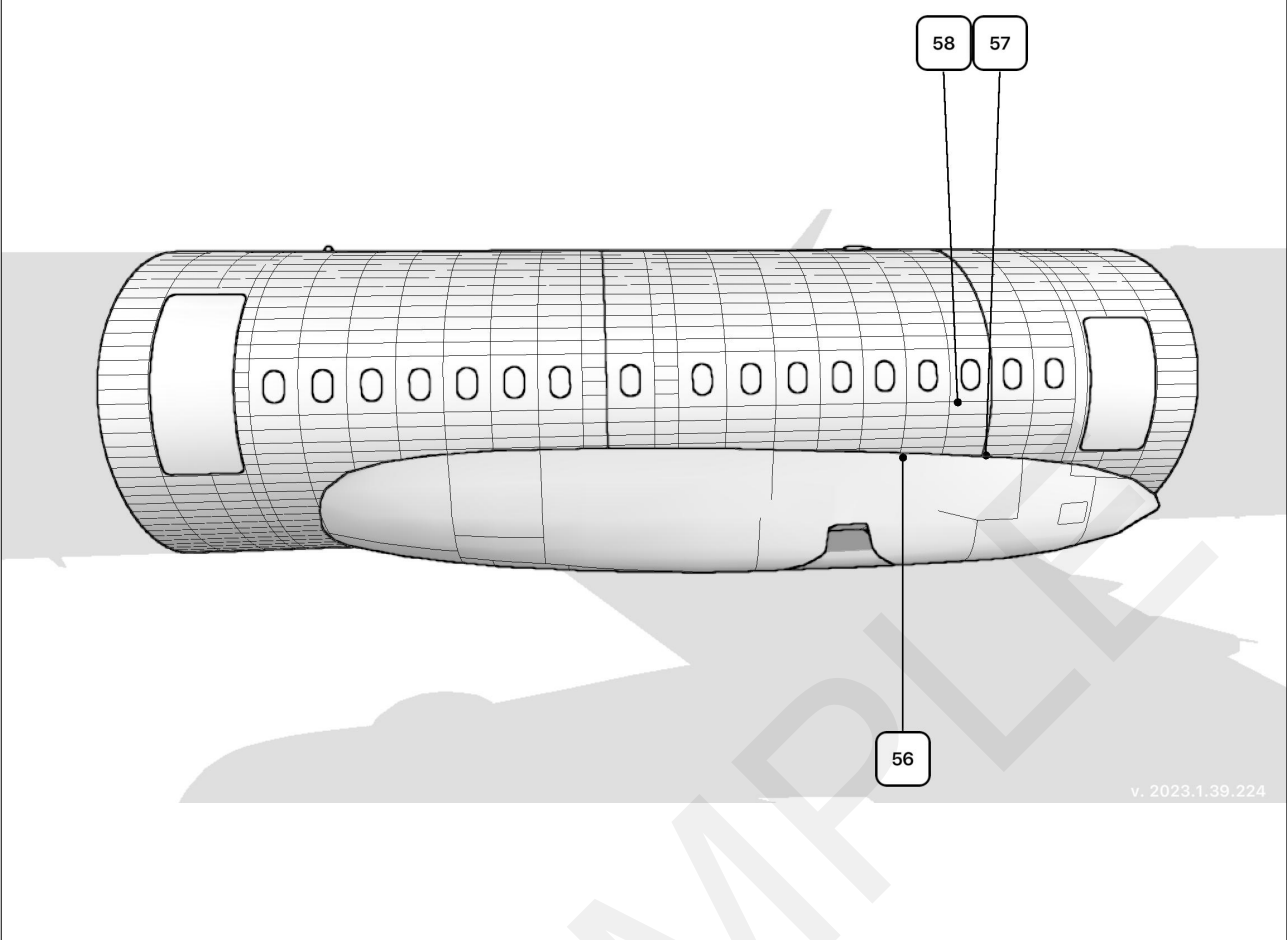
Mid LH

| No | Type | Location | Description | Date |
|---|---|---|---|---|
| 56 | Damage | FR45 + 50.00mm, STRG23LH + 10.00mm | Corrosion on Fuselage - Section 11/12 LH FR45 STRG23 | 20/10/2022 |
| 57 | Damage | FR47 + 50.00mm, STRG23LH + 10.00mm | Corrosion on Fuselage - Section 11/12 LH FR47 STRG23 | 29/10/2022 |
| 58 | Damage | FR46 + 104.00mm, STRG18LH + 9.00mm | Corrosion on Fuselage - Section 11/12 LH FR47 STRG23 | 30/10/2022 |

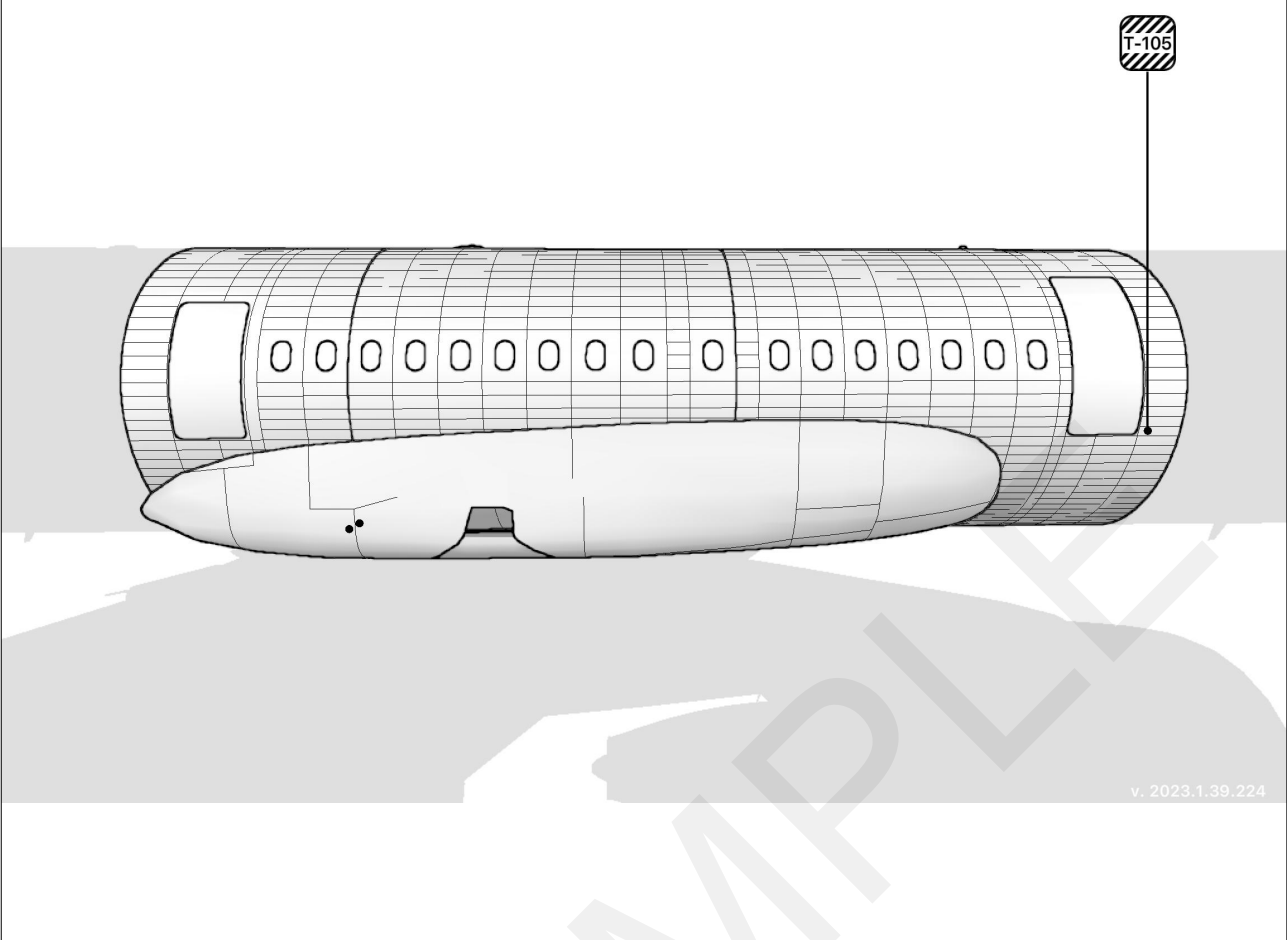
Mid RH

| No | Type | Location | Description | Date |
|---|---|---|---|---|
| T-105* | Damage | FR35 + 413.00mm, STRG22RH + 61.00mm | Dent fwd rh door no 2 | 03/12/2023 |

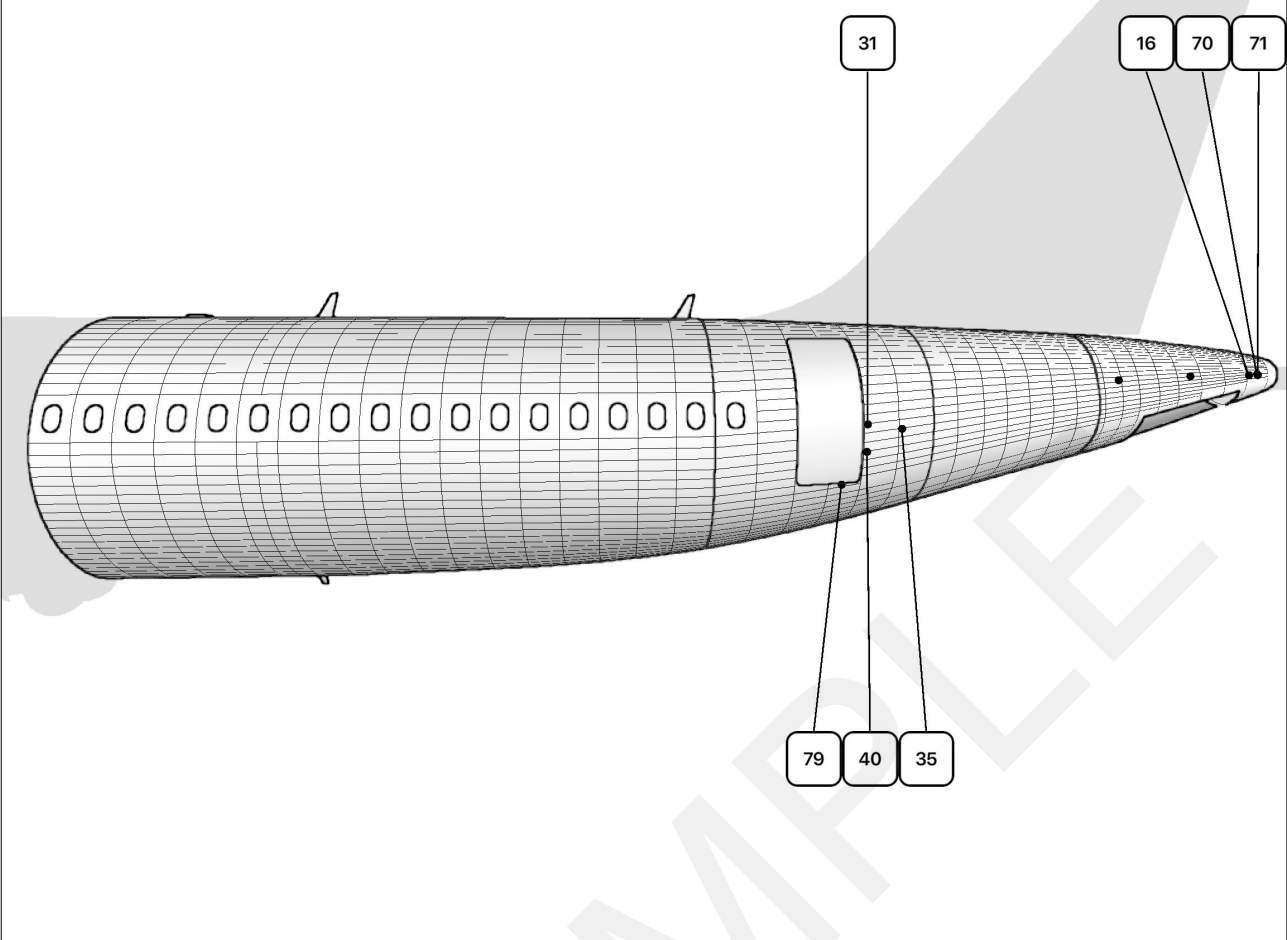
Aft LH

| No | Type | Location | Description | Date |
|---|---|---|---|---|
| 16 | Damage | FR85 + 50.00mm, STRG17LH + 10.00mm | Dent on Fuselage - Section 15/21 LH FR85 STRG17 | 27/02/2018 |
| 31 | Damage | FR68 + 50.00mm, STRG18LH + 10.00mm | Dent on Fuselage - Section 15/21 LH FR68 STRG18 | 31/03/2018 |
| 35 | Damage | FR69 + 50.00mm, STRG19LH + 10.00mm | Dent on Fuselage - Section 15/21 LH FR69 STRG19 | 23/08/2021 |
| 40 | Damage | FR68 + 50.00mm, STRG21LH + 10.00mm | Scratch on Fuselage - Section 15/21 LH FR68 STRG21 | 23/08/2021 |
| 70 | Damage | FR85 + 228.00mm, STRG17LH + 6.00mm | Dent on Fuselage - Section 15/21 LH FR85 STRG16 | 12/11/2022 |
| 71 | Damage | FR85 + 245.00mm, STRG17LH + 18.00mm | Dent on Horizontal Stabilizer Leading Edge RH | 13/11/2022 |
| 79 | Damage | FR67 + 204.00mm, STRG24LH + 90.00mm | Corrosion on Fuselage L2 Door Sill - Section 11/12 LH FR67 STRG24 | 21/11/2022 |

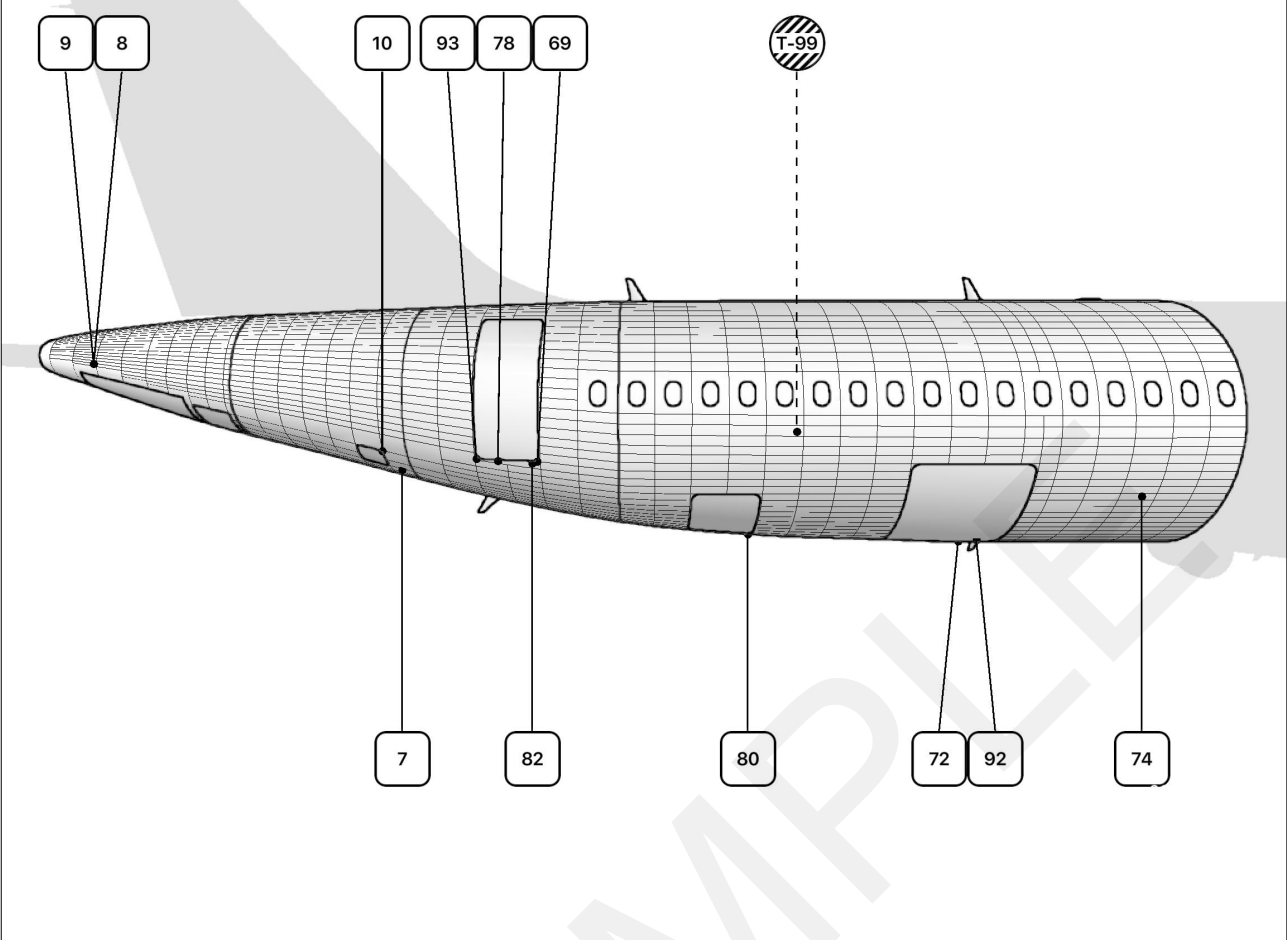
Aft RH

| No | Type | Location | Description | Date |
|---|---|---|---|---|
| T-99* | Repair | FR59 + 94.00mm, STRG19RH + 93.00mm | Dent - Fuse. Skin, FR59, S19R-S20R | 26/09/2023 |
| 7 | Damage | FR70 + 227.00mm, STRG31RH + 85.00mm | Corrosion on Fuselage - Section 15/21 RH FR69 STRG30 | 07/07/2016 |
| 8 | Damage | FR84 + 50.00mm, STRG19RH + 10.00mm | Dent on Fuselage - Section 15/21 RH FR84 STRG19 | 01/04/2017 |
| 9 | Damage | FR84 + 50.00mm, STRG19RH + 10.00mm | Dent on Fuselage - Section 15/21 RH FR84 STRG19 | 01/04/2017 |
| 10 | Damage | FR71 + 11.00mm, STRG27RH + 20.00mm | Dent on Fuselage - Section 15/21 RH FR71 STRG27 | 03/04/2017 |
| 69 | Damage | FR66 + 42.00mm, STRG24RH + 6.00mm | Corrosion on Fuselage - Section 11/12 RH FR66 STRG23 | 11/11/2022 |
| 72 | Damage | FR53 + 263.00mm, STRG39RH + 58.00mm | Corrosion on Fuselage - Section 11/12 RH FR53 STRG38 | 14/11/2022 |
| 74 | Damage | FR49 + 200.00mm, STRG27RH + 60.00mm | Crack on Wing-to-Body Fairing RH FR49 STRG27 | 16/11/2022 |
| 78 | Damage | FR67 + 138.00mm, STRG24RH + 86.00mm | Corrosion on Fuselage R2 Door Sill - Section 11/12 RH FR67 STRG24 | 20/11/2022 |
| 80 | Damage | FR60 + 50.00mm, STRG38RH + 10.00mm | Corrosion on Fuselage Bulk Cargo Door Sill- Section 11/12 RH FR60 STRG38 | 22/11/2022 |
| 82 | Damage | FR66 + 120.00mm, STRG24RH + 49.00mm | Corrosion on Fuselage R2 Door Sill - Section 11/12 RH FR66 STRG23 | 24/11/2022 |
| 92 | Damage | AFT CARGO DOOR - 826 | Corrosion on Aft Cargo Door | 04/12/2022 |
| 93 | Damage | FR67 + 468.00mm, STRG24RH + 103.00mm | Corrosion on Fuselage - Section 11/12 RH FR67 STRG24 | 05/12/2022 |

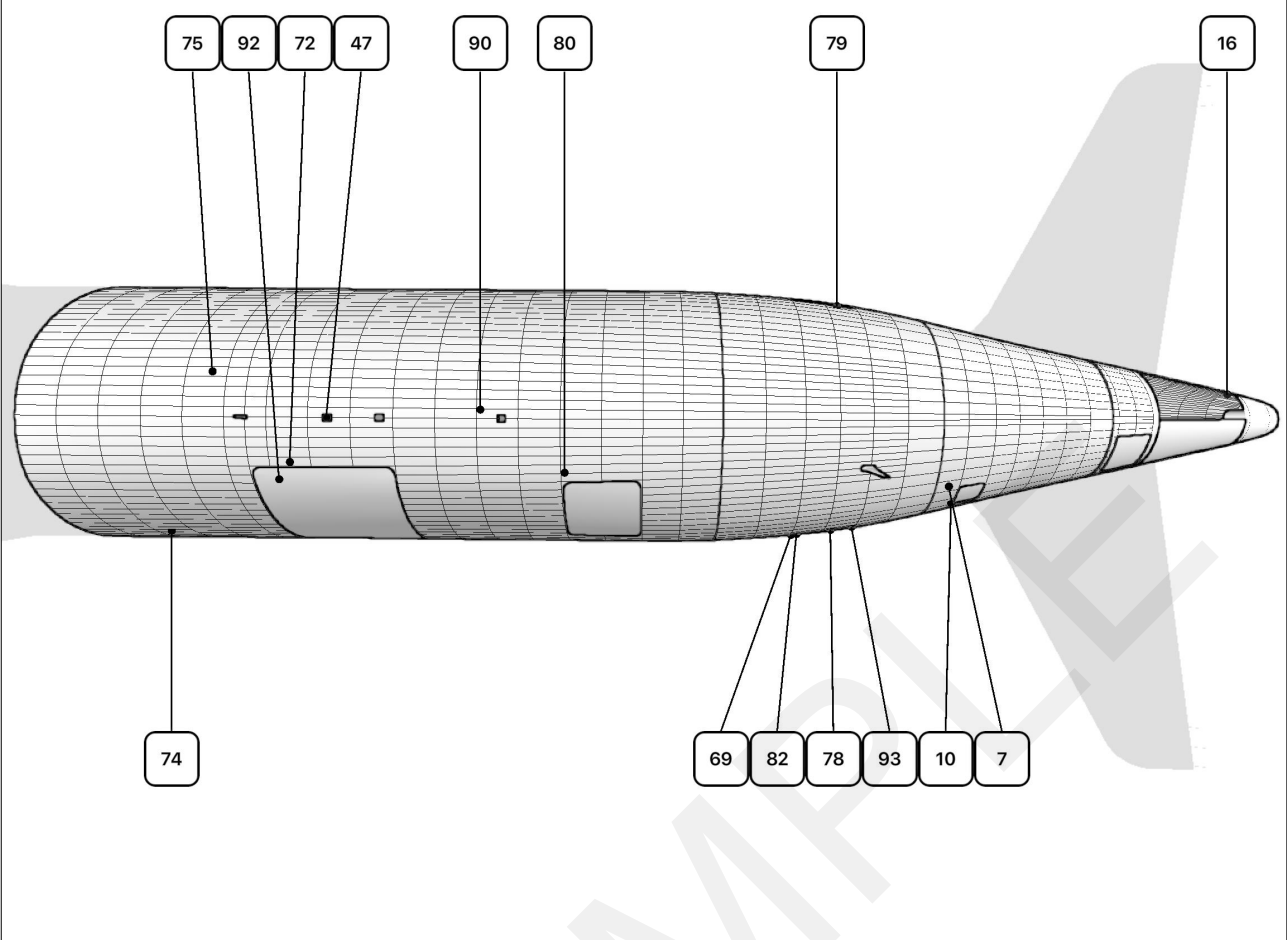
Aft Top

| No | Type | Location | Description | Date |
|---|---|---|---|---|
| 7 | Damage | FR70 + 227.00mm, STRG31RH + 85.00mm | Corrosion on Fuselage - Section 15/21 RH FR69 STRG30 | 07/07/2016 |
| 10 | Damage | FR71 + 11.00mm, STRG27RH + 20.00mm | Dent on Fuselage - Section 15/21 RH FR71 STRG27 | 03/04/2017 |
| 16 | Damage | FR85 + 50.00mm, STRG17LH + 10.00mm | Dent on Fuselage - Section 15/21 LH FR85 STRG17 | 27/02/2018 |
| 47 | Damage | ANTENNA RADIO ALTIMETER - 5SA1 | Marking Missing on ANTENNA RADIO ALTIMETER - 5SA1 | 15/01/2022 |
| 69 | Damage | FR66 + 42.00mm, STRG24RH + 6.00mm | Corrosion on Fuselage - Section 11/12 RH FR66 STRG23 | 11/11/2022 |
| 72 | Damage | FR53 + 263.00mm, STRG39RH + 58.00mm | Corrosion on Fuselage - Section 11/12 RH FR53 STRG38 | 14/11/2022 |
| 74 | Damage | FR49 + 200.00mm, STRG27RH + 60.00mm | Crack on Wing-to-Body Fairing RH FR49 STRG27 | 16/11/2022 |
| 92 | Damage | AFT CARGO DOOR - 826 | Corrosion on Aft Cargo Door | 04/12/2022 |

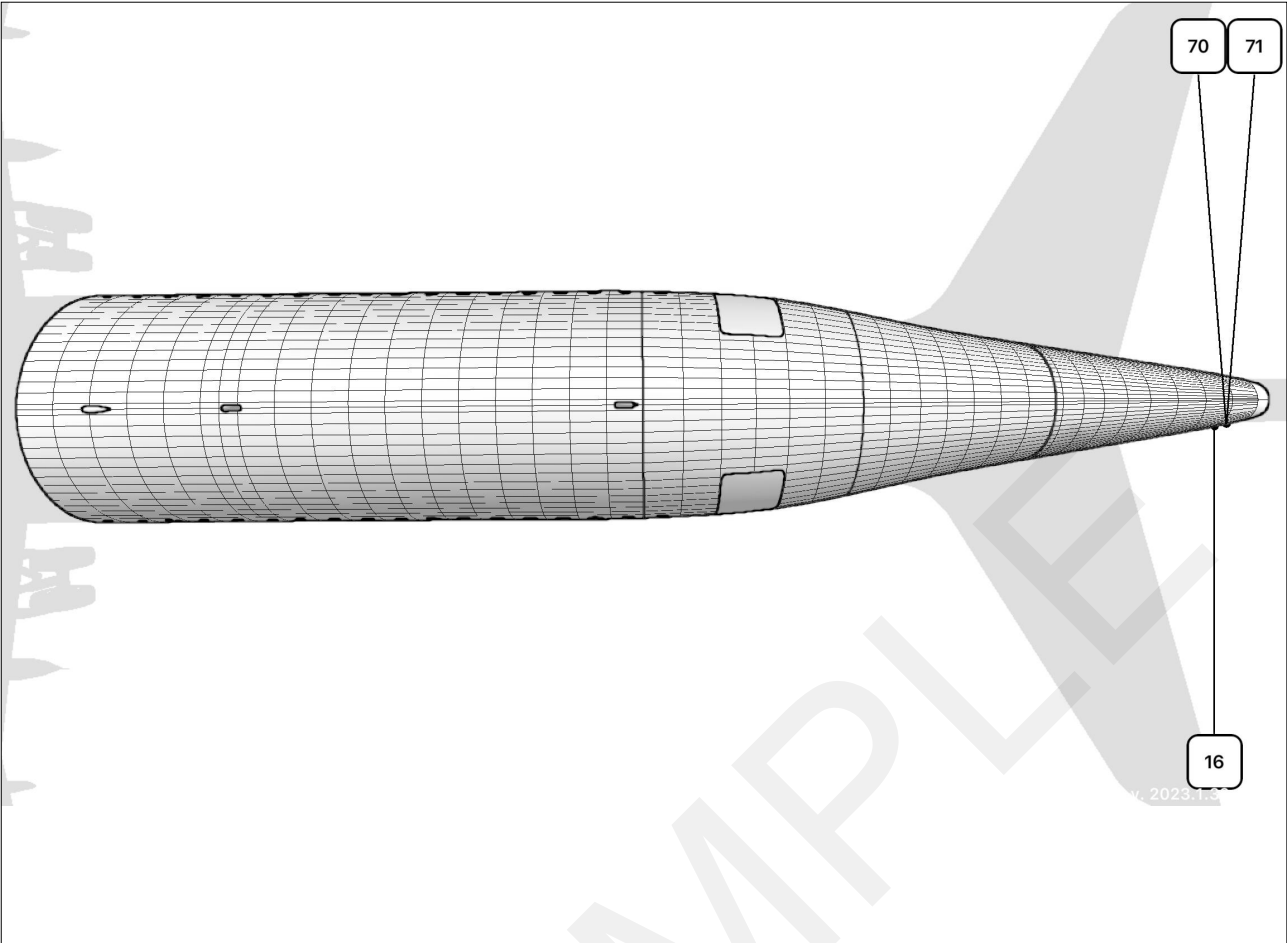
Aft Lower

| No | Type | Location | Description | Date |
|---|---|---|---|---|
| 70 | Damage | FR85 + 228.00mm, STRG17LH + 6.00mm | Dent on Fuselage - Section 15/21 LH FR85 STRG16 | 12/11/2022 |
| 71 | Damage | FR85 + 245.00mm, STRG17LH + 18.00mm | Dent on Horizontal Stabilizer Leading Edge RH | 13/11/2022 |

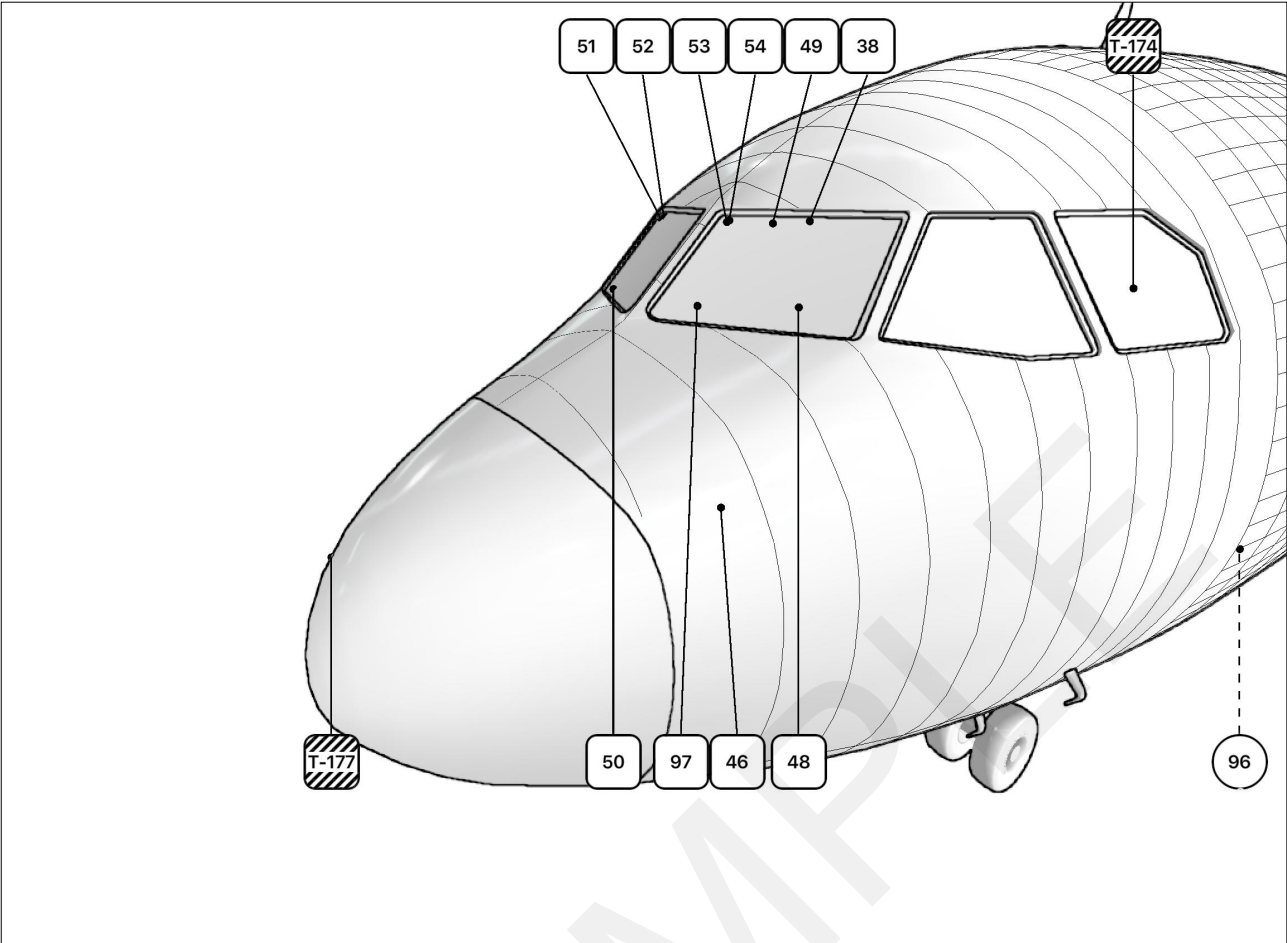
Cockpit Windows LH

| No | Type | Location | Description | Date |
|---|---|---|---|---|
| 96 | Repair | FR12 + 50.00mm, STRG23LH + 10.00mm | sheared Fasteners on Fuselage - Section 11/12 LH FR12 STRG23 | 08/12/2022 |
| 97 | Damage | Cockpit Window | Scratches - Flight Deck Captain Sliding Window Inner Panel | 26/09/2023 |

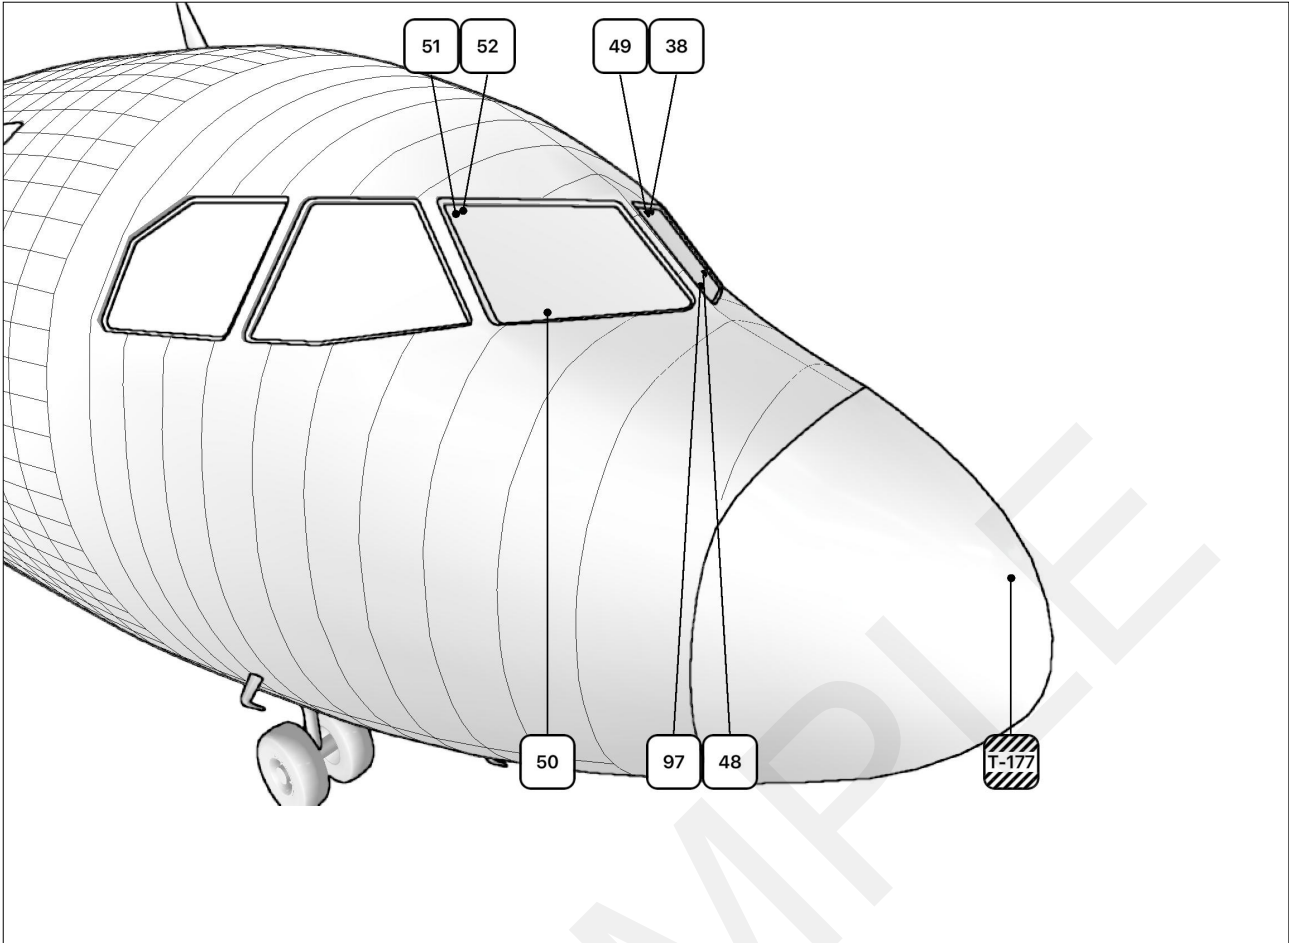
Cockpit Windows RH

| No | Type | Location | Description | Date |
|---|---|---|---|---|
| 97 | Damage | Cockpit Window | Scratches - Flight Deck Captain Sliding Window Inner Panel | 26/09/2023 |

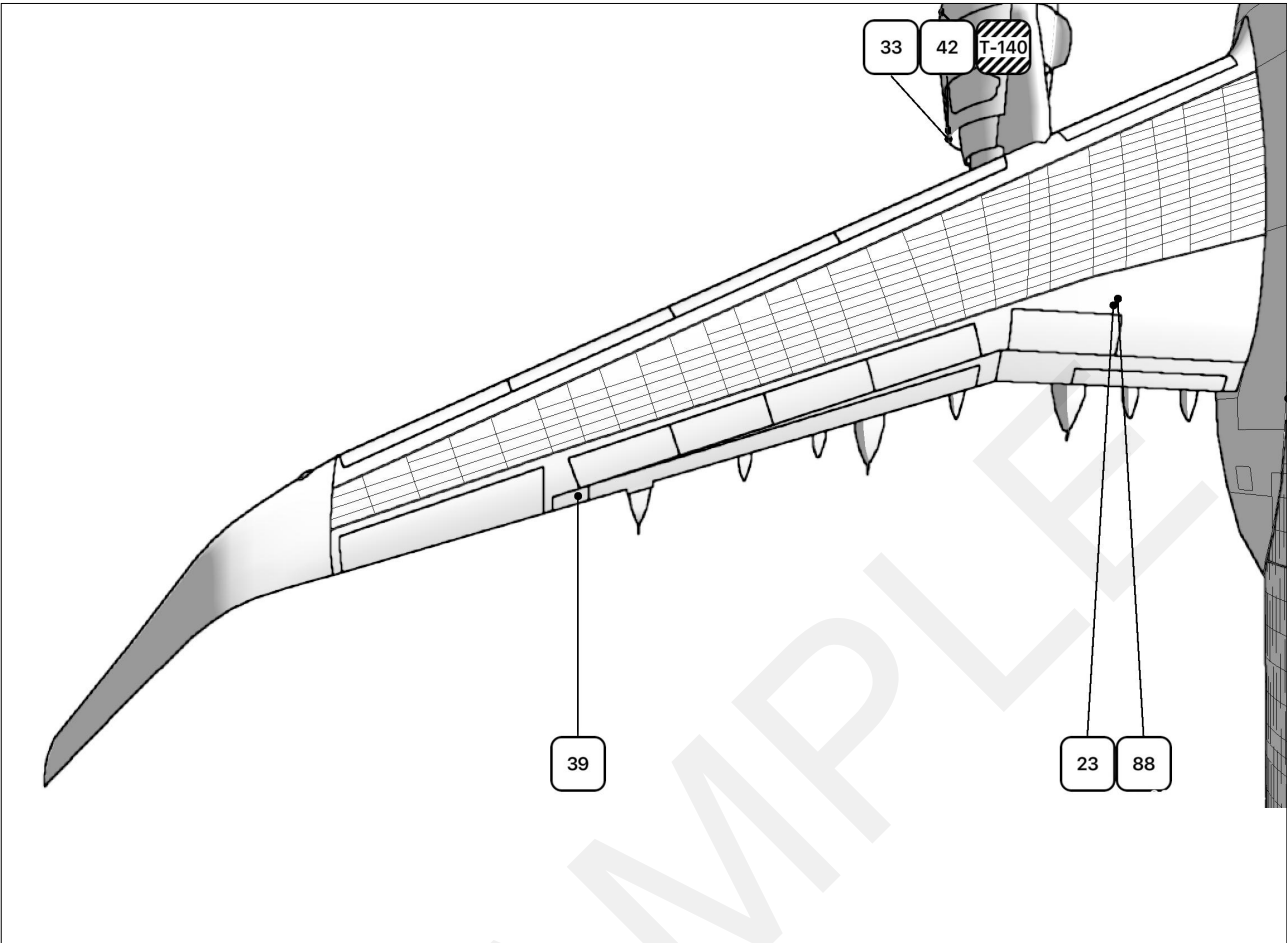
LH Top

| No | Type | Location | Description | Date |
|---|---|---|---|---|
| 42 | Damage | Cowl Assy 2 Inboard LH | Dent on COWL ASSY-AIR INLET - 1100KM1 | 10/03/2018 |
| 88 | Damage | Wing LH B | Corrosion on Wing LH 1 | 30/11/2022 |

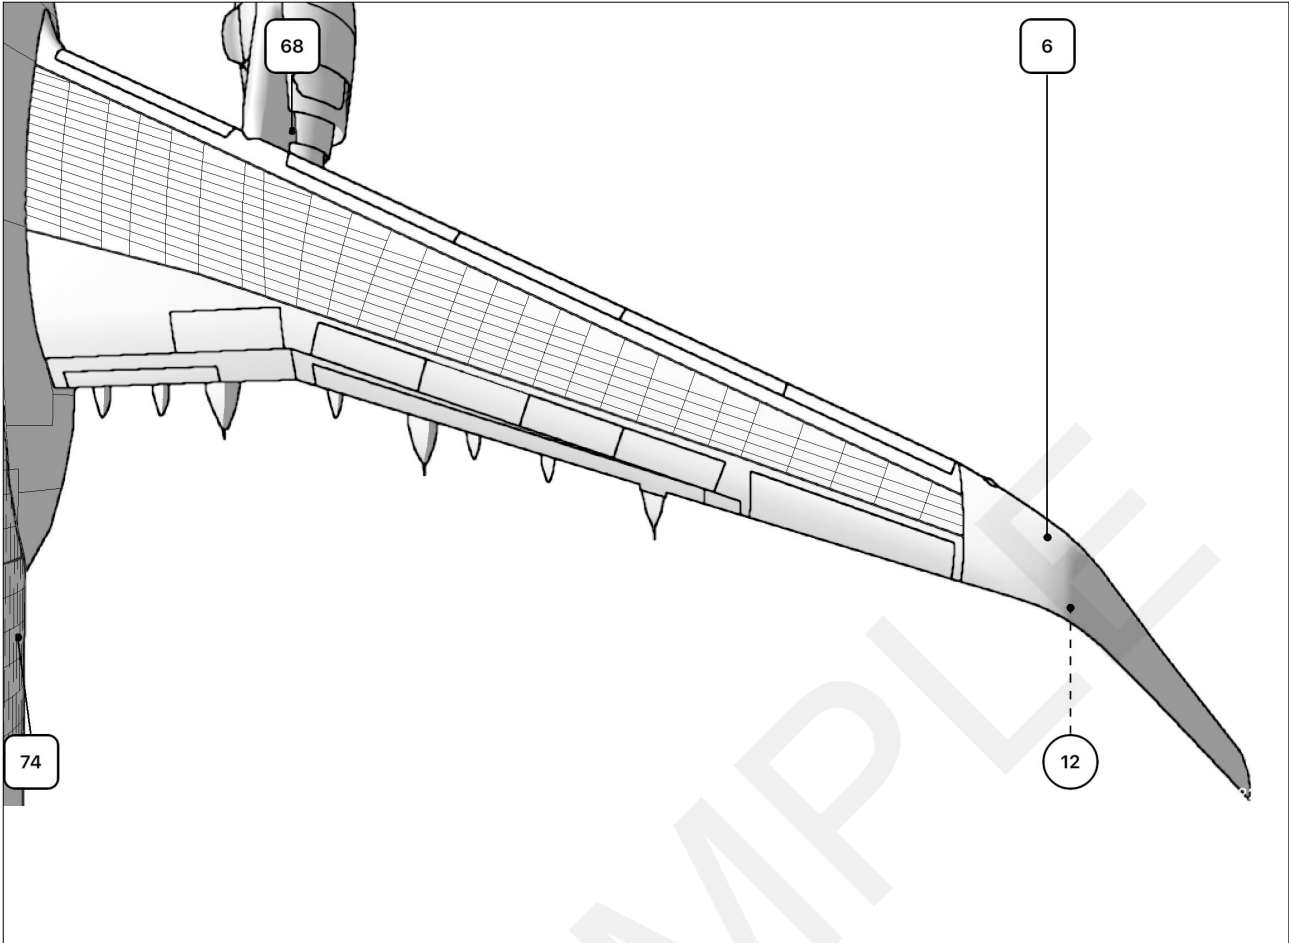
RH Top

| No | Type | Location | Description | Date |
|---|---|---|---|---|
| 68 | Damage | PYLON AFT FIXED FAIRING RH - 001 | Chafing on PYLON AFT FIXED FAIRING RH - 001 | 10/11/2022 |
| 74 | Damage | FR49 + 200.00mm, STRG27RH + 60.00mm | Crack on Wing-to-Body Fairing RH FR49 STRG27 | 16/11/2022 |

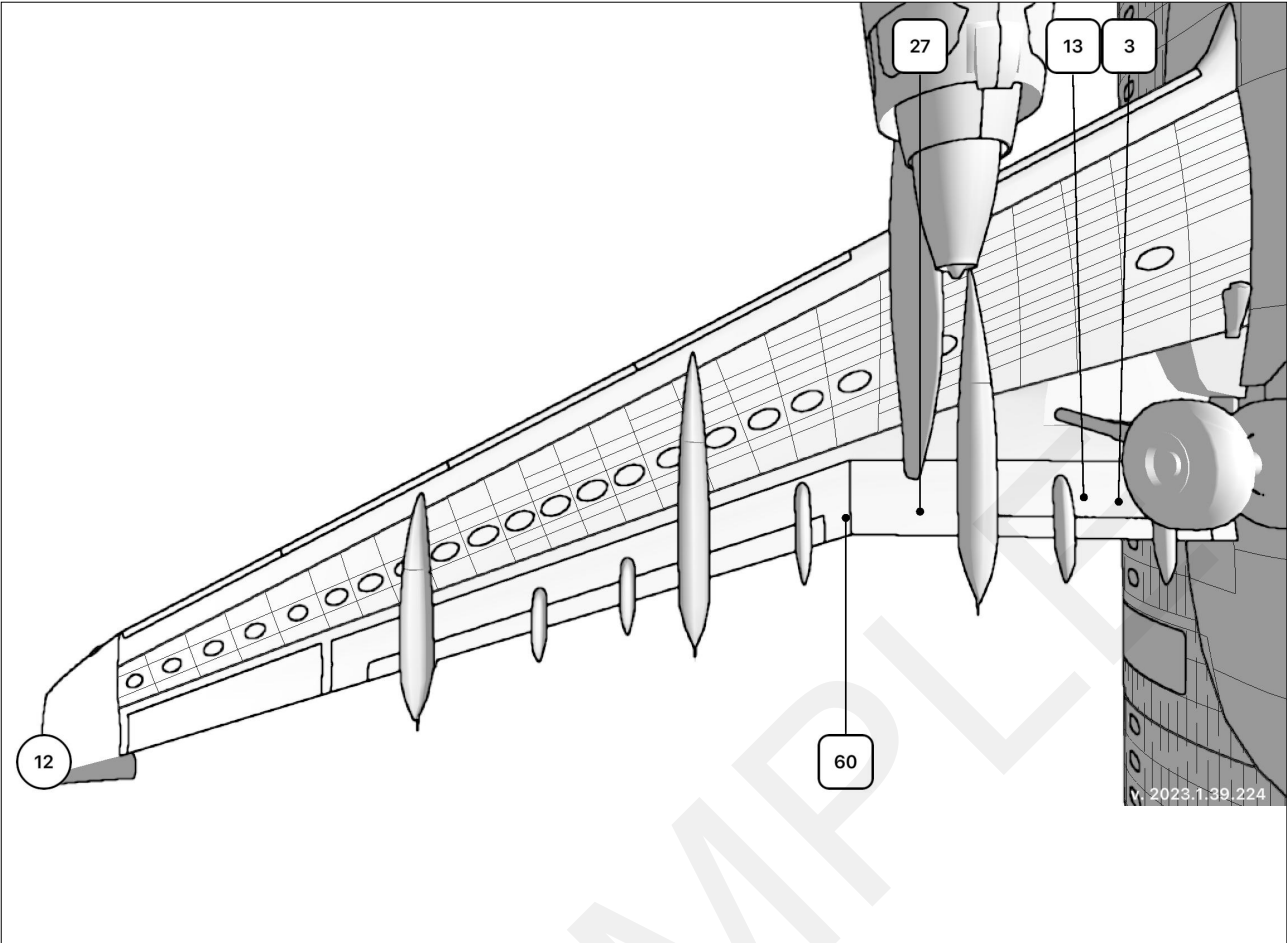
RH Lower

| No | Type | Location | Description | Date |
|---|---|---|---|---|
| 27 | Damage | Inboard Flap 1 RH | Dent on LH INBOARD FLAP LOWER SURFACE | 01/04/2018 |
| 60 | Damage | Outboard Flap 1 RH | Chafing on Outboard Flap 1 RH | 01/11/2022 |
