## DAMAGE CHART

A/C Reg: T-A321C

Type: A321i

Effective date: 04-Jun-2025 / 07:21 UTC

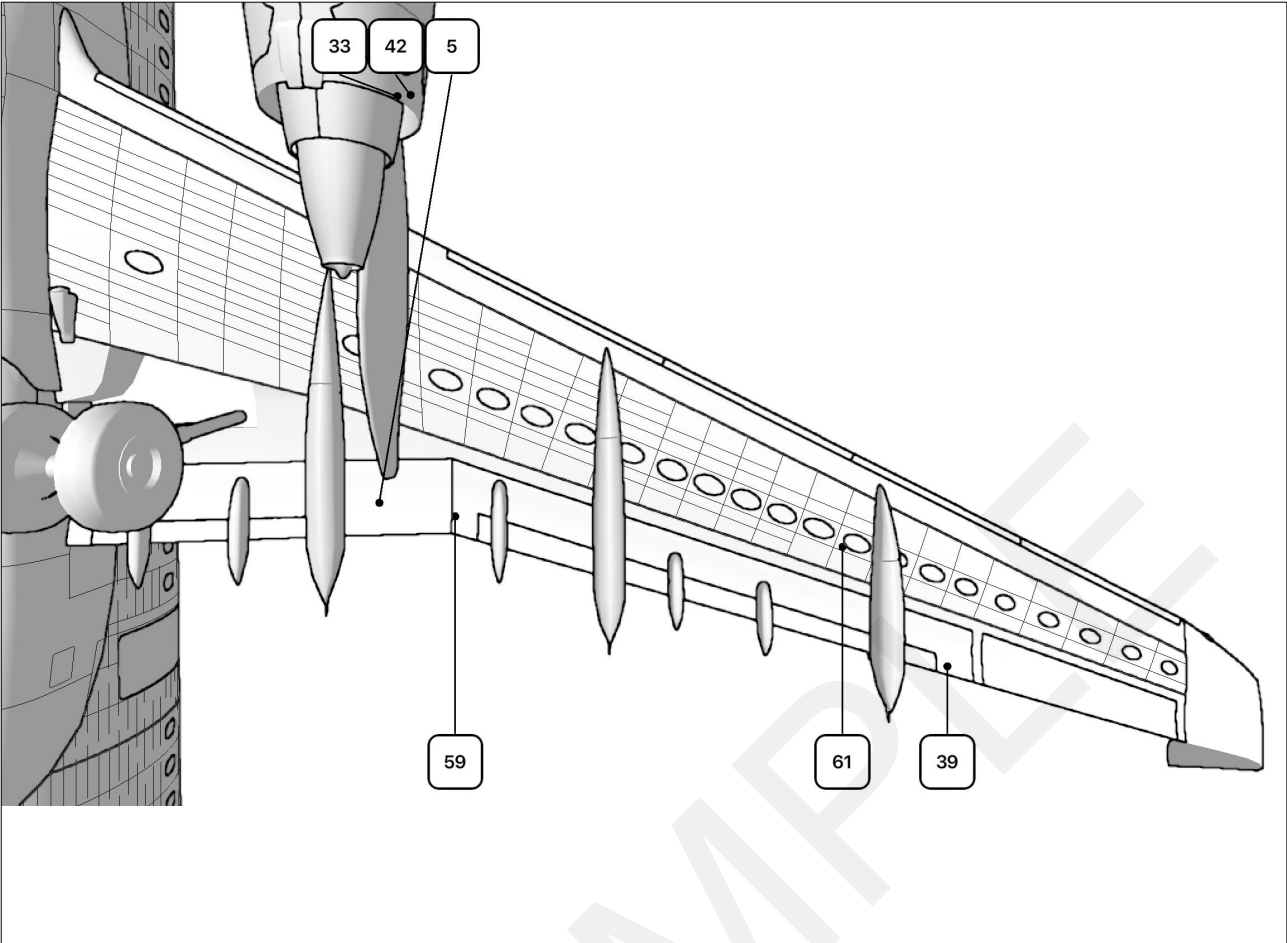
LH Lower

| No | Type | Location | Description | Date |
|---|---|---|---|---|
| 61 | Damage | Wing LH A | Corrosion on Wing LH 1 | 02/11/2022 |

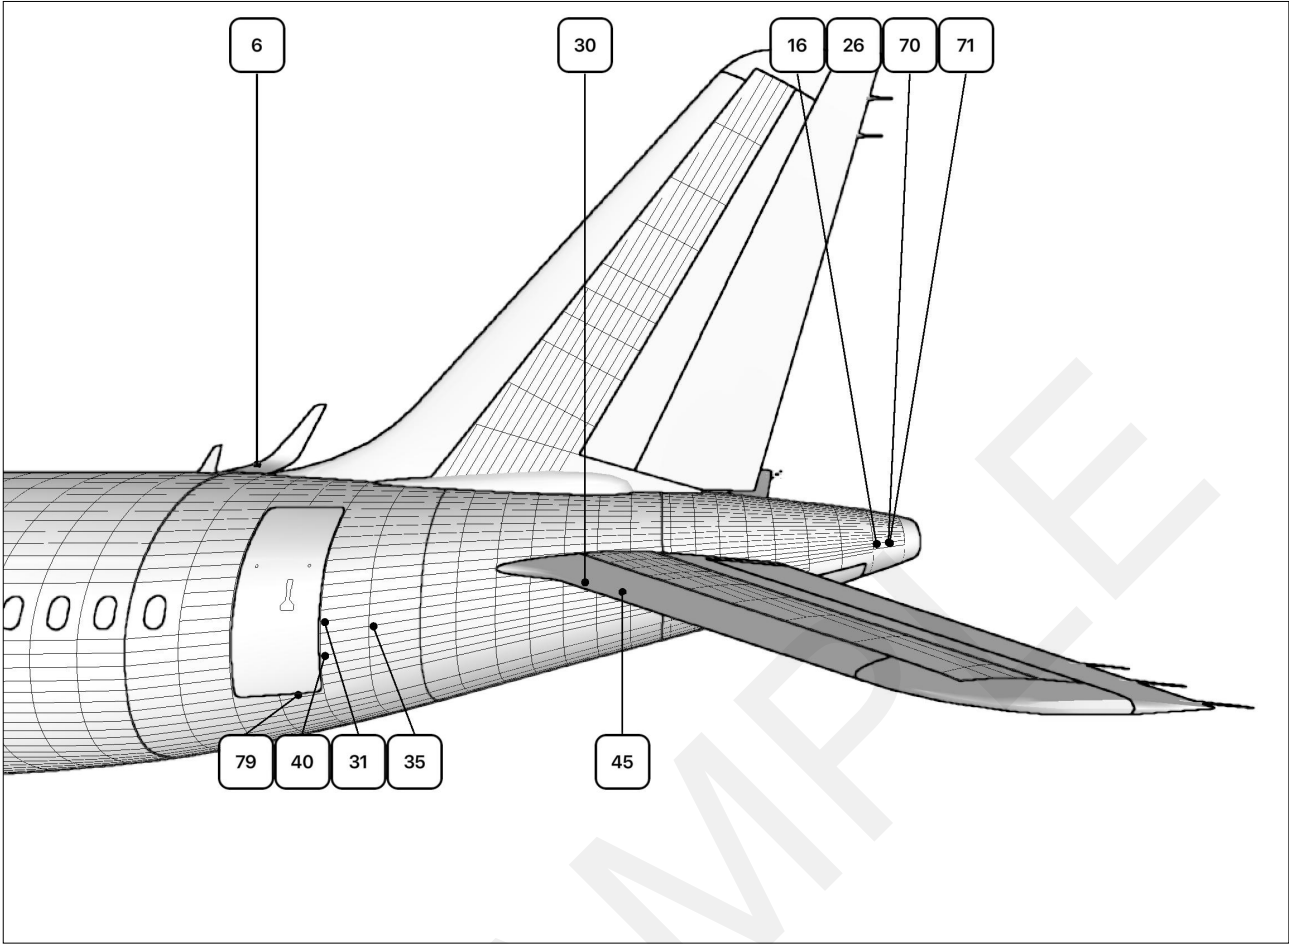
Vert Stab. LH

| No | Type | Location | Description | Date |
|---|---|---|---|---|
| 71 | Damage | FR85 + 245.00mm, STRG17LH + 18.00mm | Dent on Horizontal Stabilizer Leading Edge RH | 13/11/2022 |
| 79 | Damage | FR67 + 204.00mm, STRG24LH + 90.00mm | Corrosion on Fuselage L2 Door Sill - Section 11/12 LH FR67 STRG24 | 21/11/2022 |

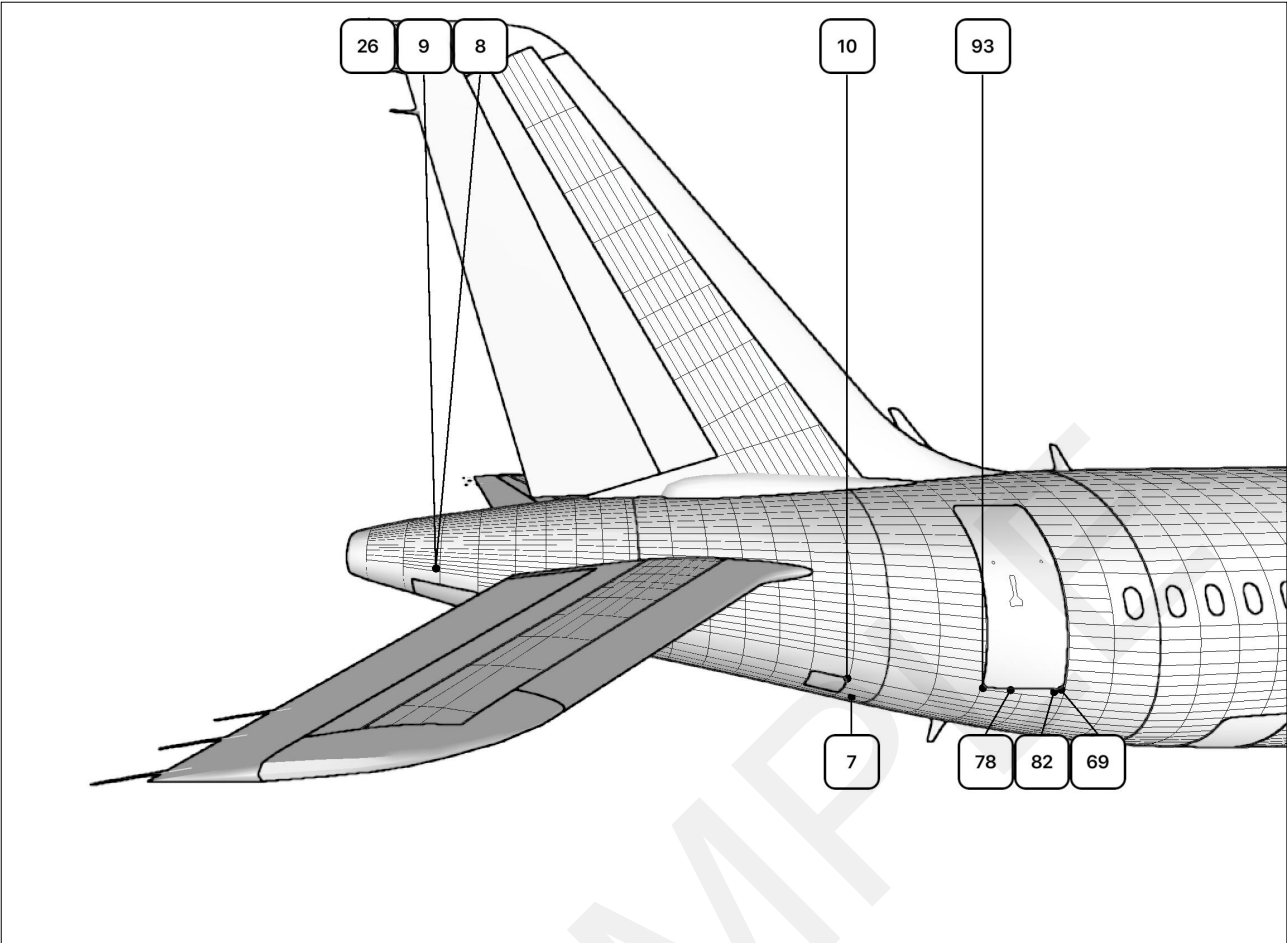
Vert Stab. RH

| No | Type | Location | Description | Date |
|---|---|---|---|---|
| 82 | Damage | FR66 + 120.00mm, STRG24RH + 49.00mm | Corrosion on Fuselage R2 Door Sill - Section 11/12 RH FR66 STRG23 | 24/11/2022 |
| 93 | Damage | FR67 + 468.00mm, STRG24RH + 103.00mm | Corrosion on Fuselage - Section 11/12 RH FR67 STRG24 | 05/12/2022 |

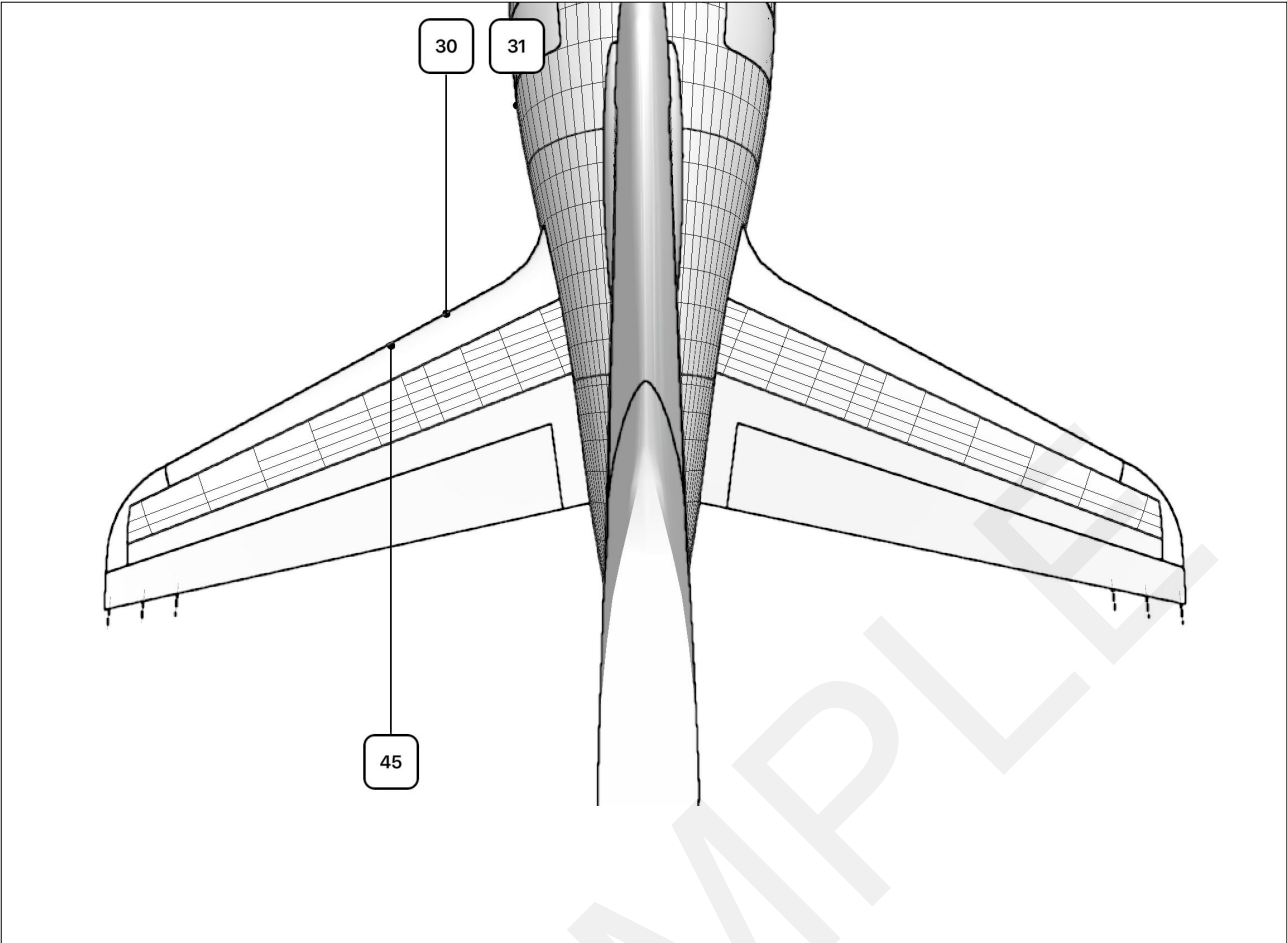
Horiz Stab. Top

| No | Type | Location | Description | Date |
|---|---|---|---|---|
| 31 | Damage | FR68 + 50.00mm, STRG18LH + 10.00mm | Dent on Fuselage - Section 15/21 LH FR68 STRG18 | 31/03/2018 |
| 45 | Damage | Horizontal Stabilizer Leading Edge LH | Dent on Horizontal Stabilizer Leading Edge LH | 21/11/2021 |

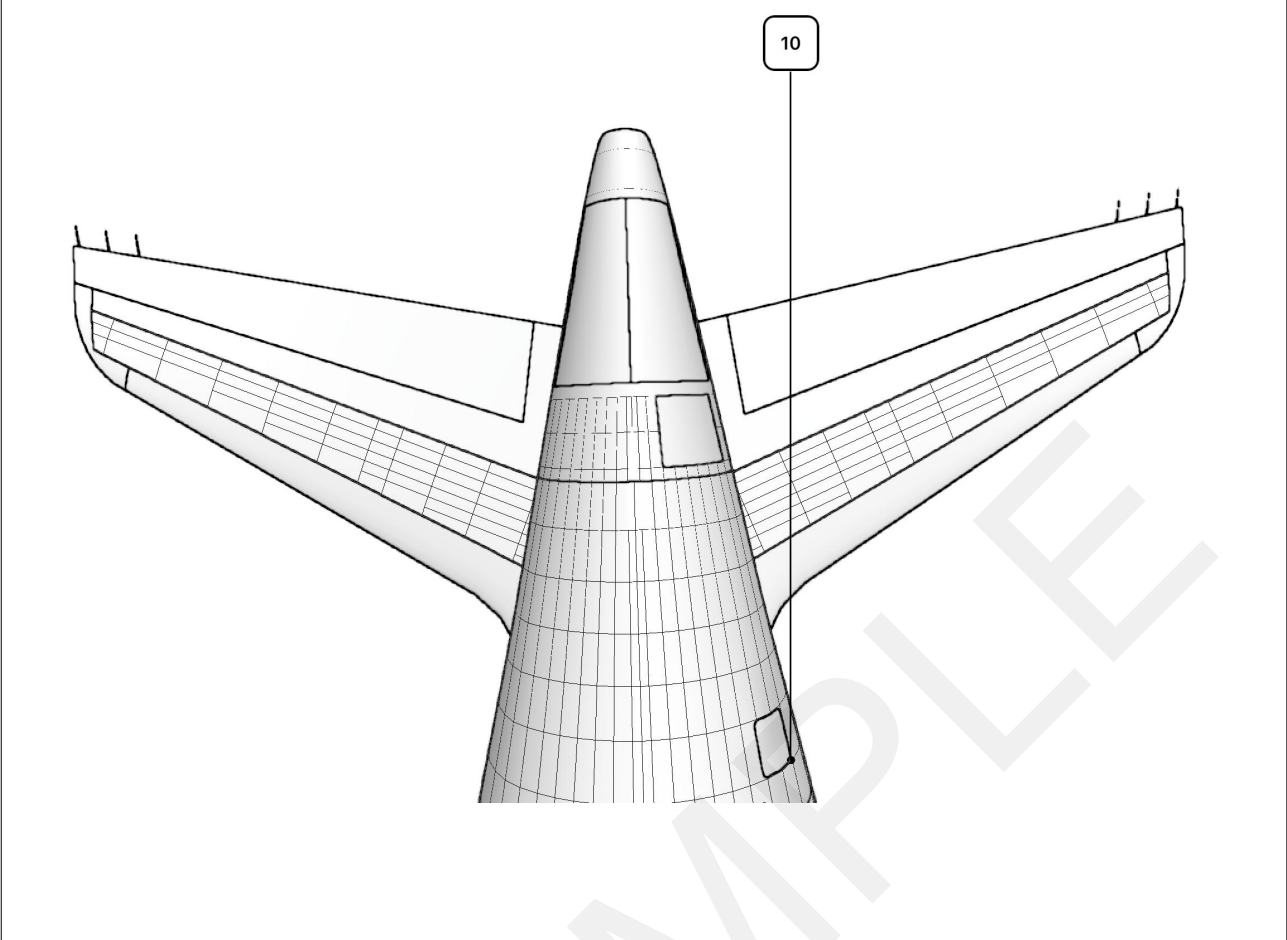
Horiz Stab. Lower

| No | Type | Location | Description | Date |
|---|---|---|---|---|
| 10 | Damage | FR71 + 11.00mm, STRG27RH + 20.00mm | Dent on Fuselage - Section 15/21 RH FR71 STRG27 | 03/04/2017 |

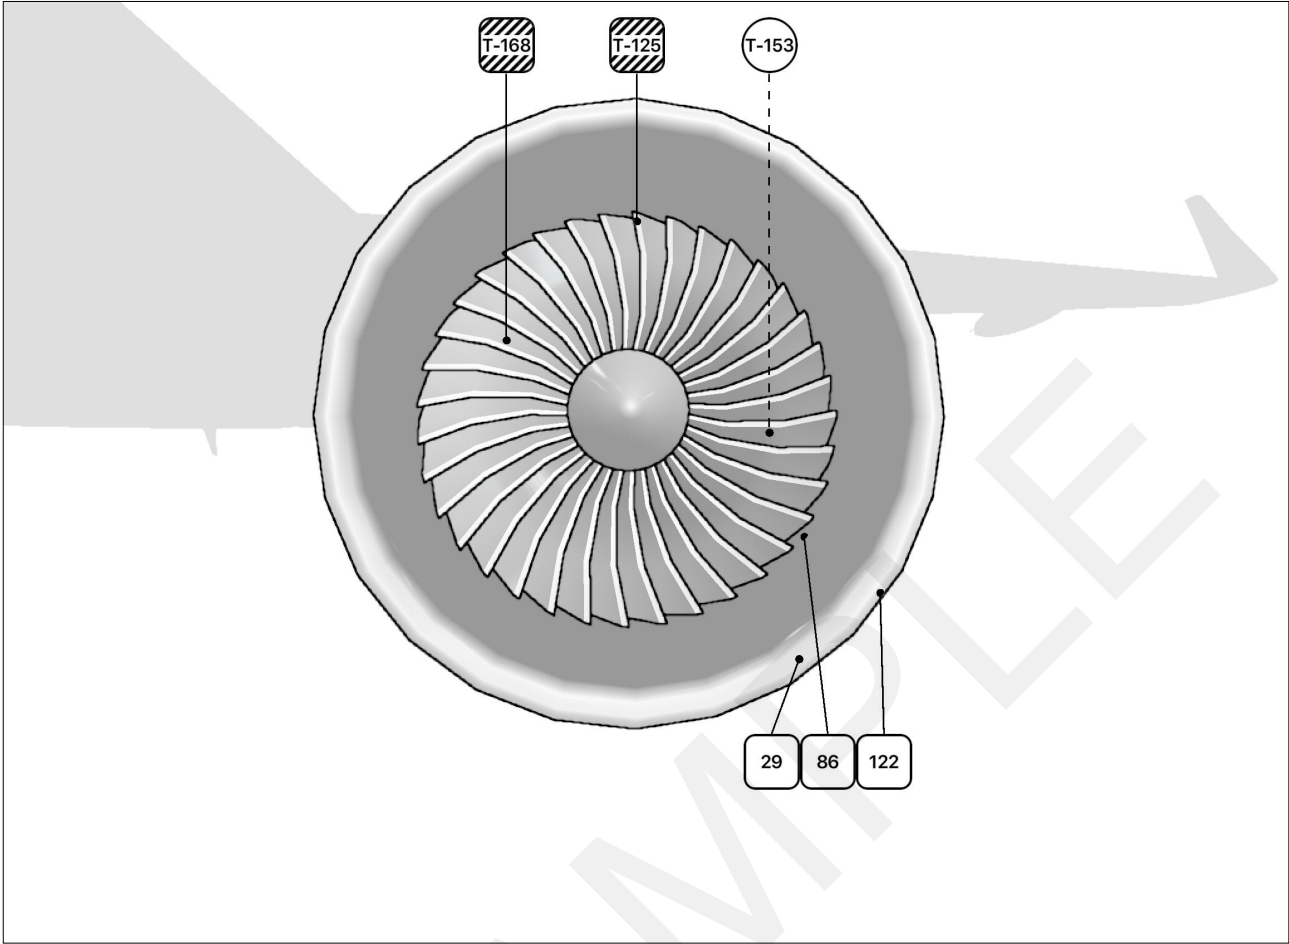
#1 Front

| No | Type | Location | Description | Date |
|---|---|---|---|---|
| 86 | Damage | COWL ASSY-AIR INLET - 1100KM1 | Abrasion on Attrition Lining - 1100KM1 | 28/11/2022 |
| 122 | Damage | COWL ASSY-AIR INLET - 1100KM1 | Dent on cowl lip | 16/04/2024 |

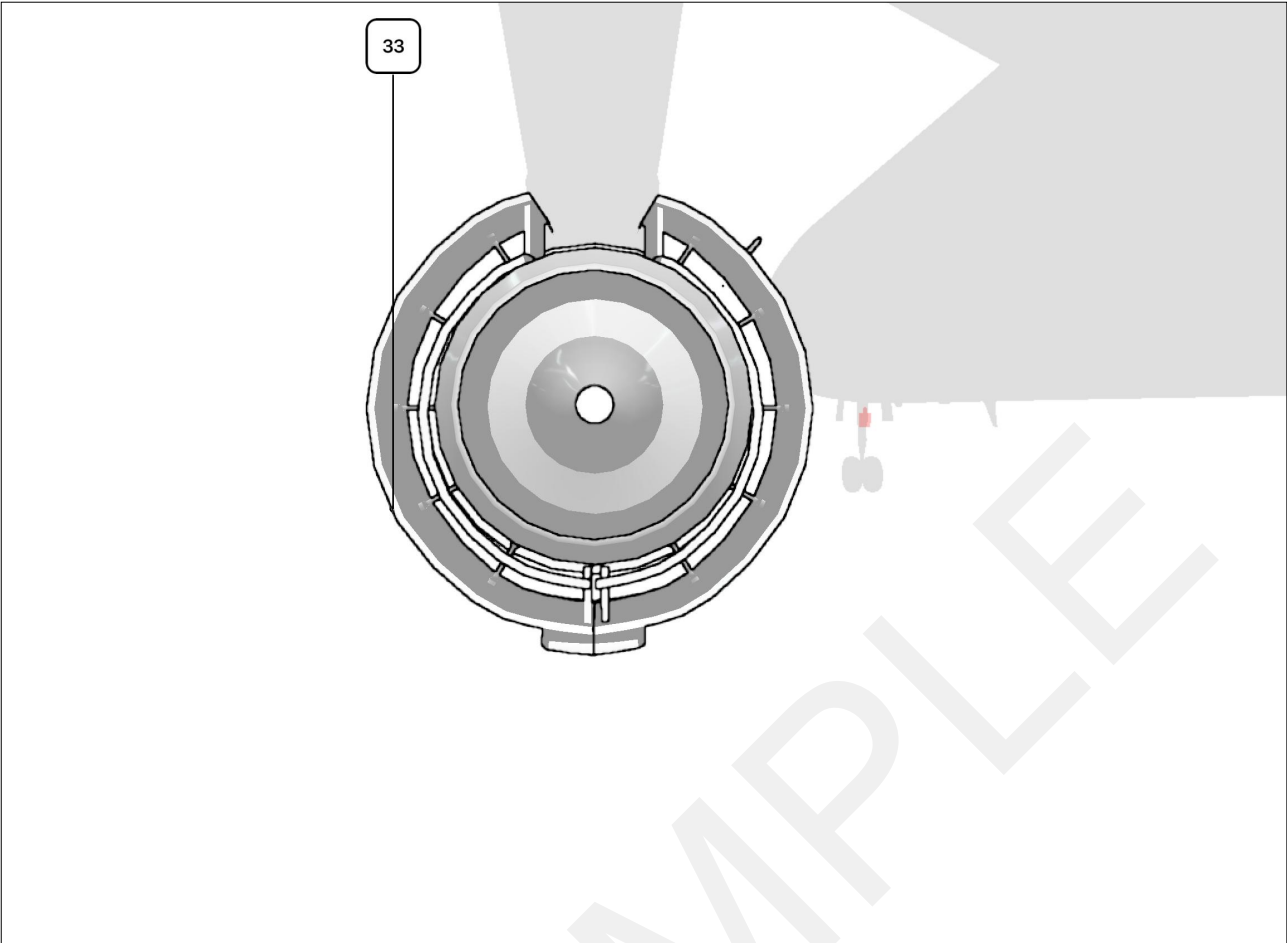
#1 Rear

| No | Type | Location | Description | Date |
|---|---|---|---|---|
| 33 | Damage | Cowl Assy 2 Inboard LH | Skin/Fastener Burn on Cowl Assy 2 Inboard LH | 12/03/2019 |

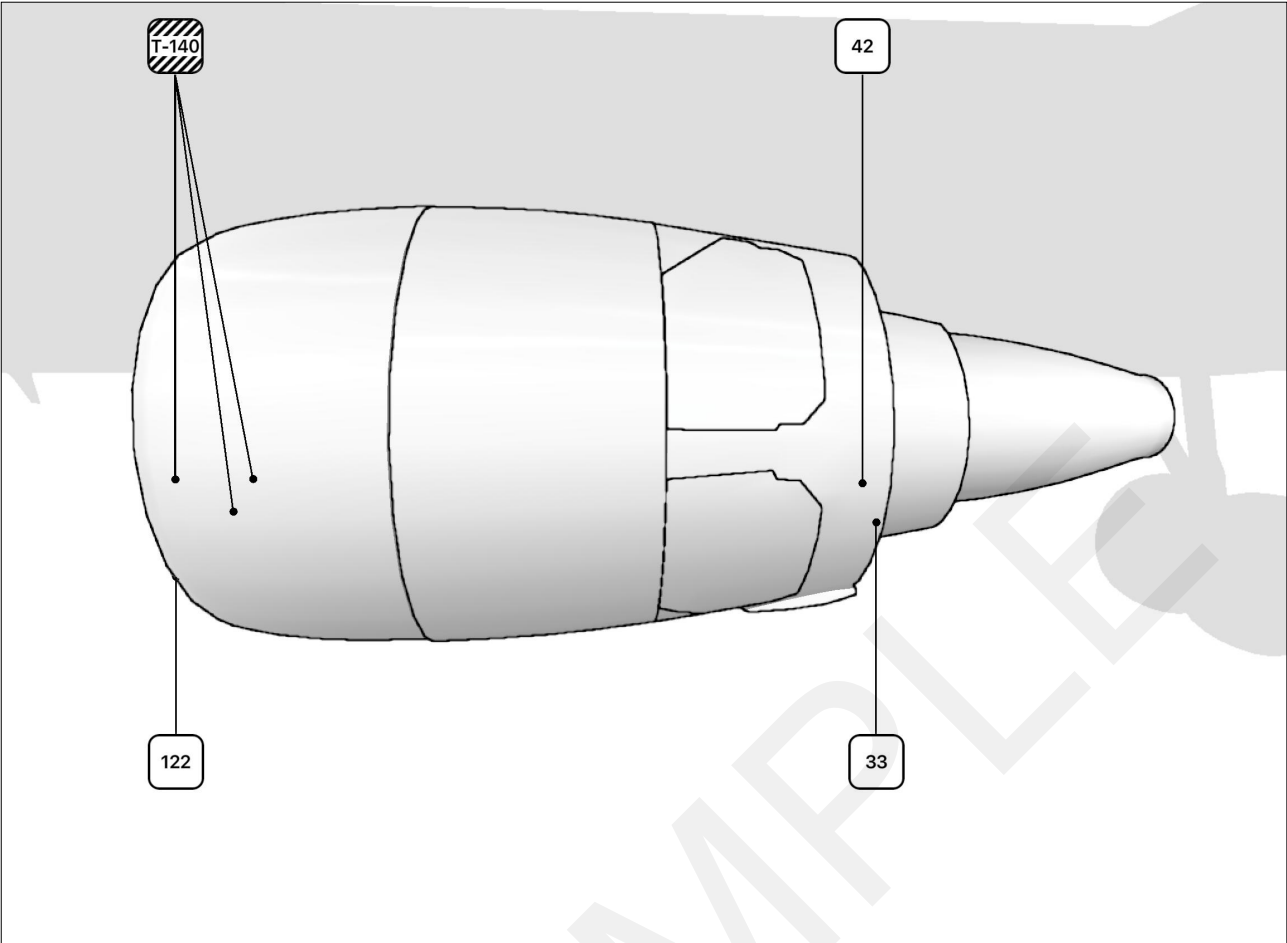
#1 LH Side

| No | Type | Location | Description | Date |
|---|---|---|---|---|
| 42 | Damage | Cowl Assy 2 Inboard LH | Dent on COWL ASSY-AIR INLET - 1100KM1 | 10/03/2018 |
| 122 | Damage | COWL ASSY-AIR INLET - 1100KM1 | Dent on cowl lip | 16/04/2024 |

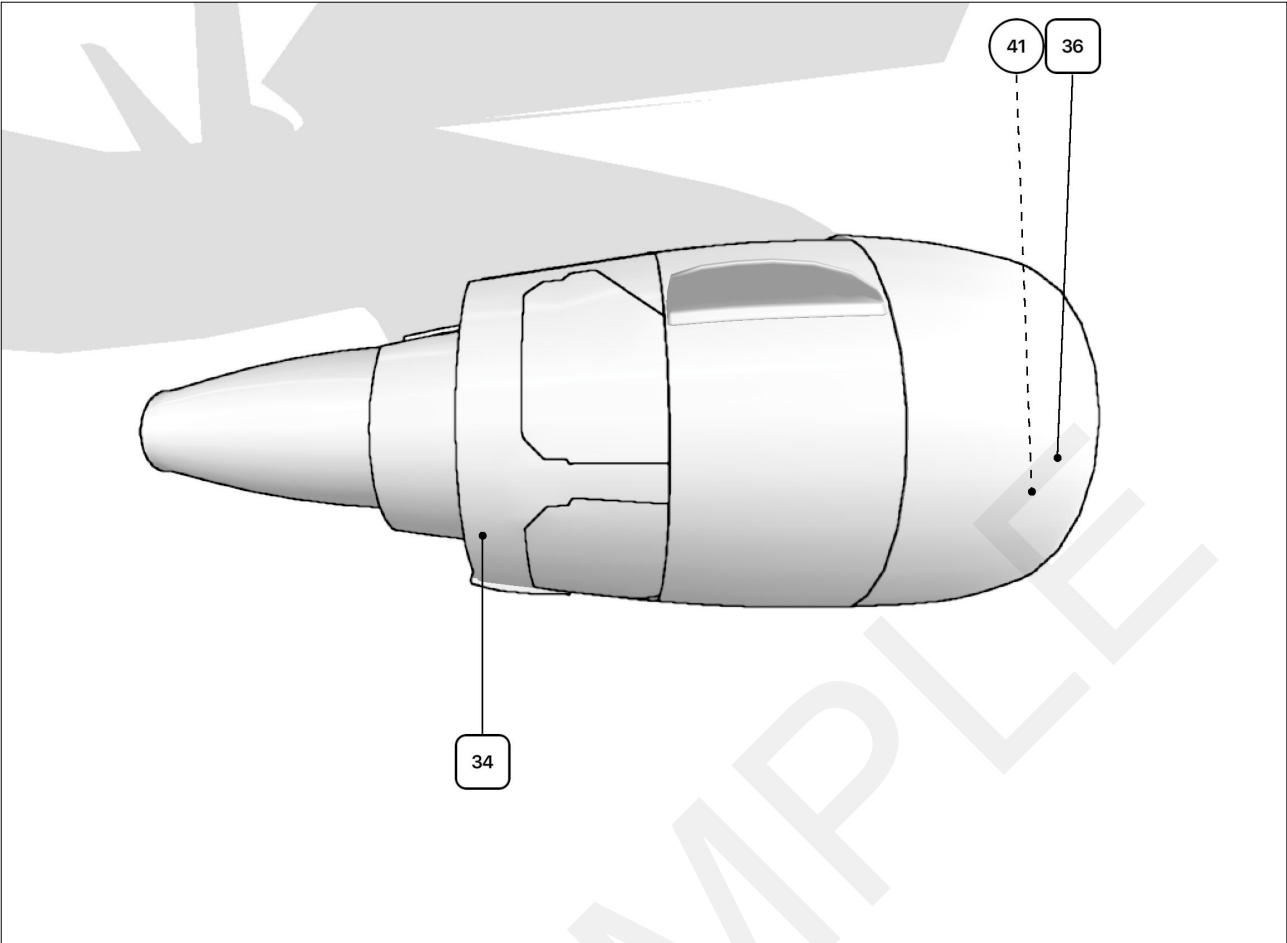
#1 RH Side

| No | Type | Location | Description | Date |
|---|---|---|---|---|
| 36 | Damage | COWL ASSY-AIR INLET - 1100KM1 | Damage on Cowl Assy 1 Inboard LH | 13/08/2019 |
| 41 | Repair | COWL ASSY-AIR INLET - 1100KM1 | Repair on COWL ASSY-AIR INLET - 1100KM1 | 19/10/2021 |

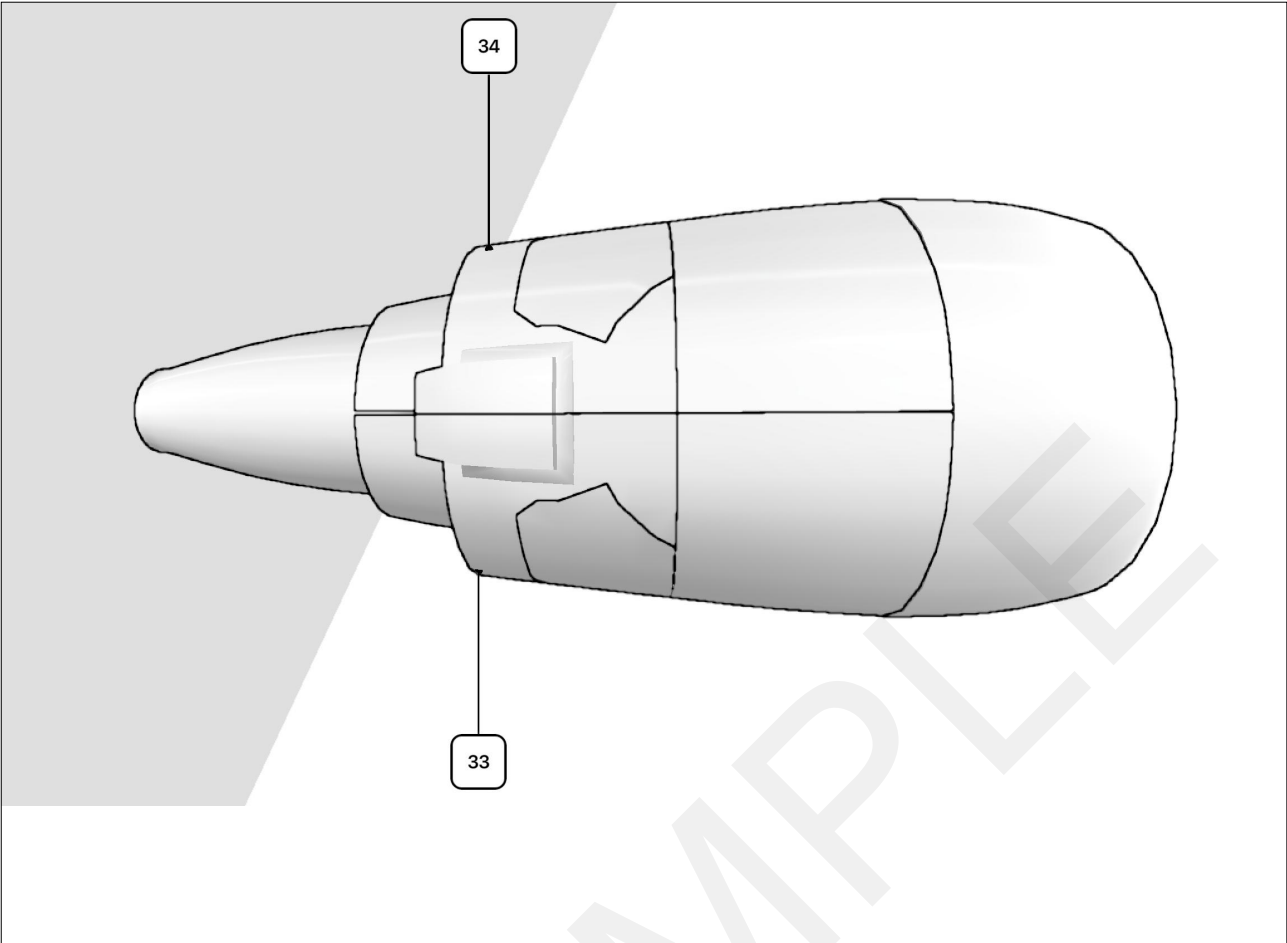
#1 Lower

| No | Type | Location | Description | Date |
|---|---|---|---|---|
| 34 | Damage | Cowl Assy 1 Inboard LH | Skin/Fastener Burn on Cowl Assy 1 Inboard LH | 13/03/2019 |

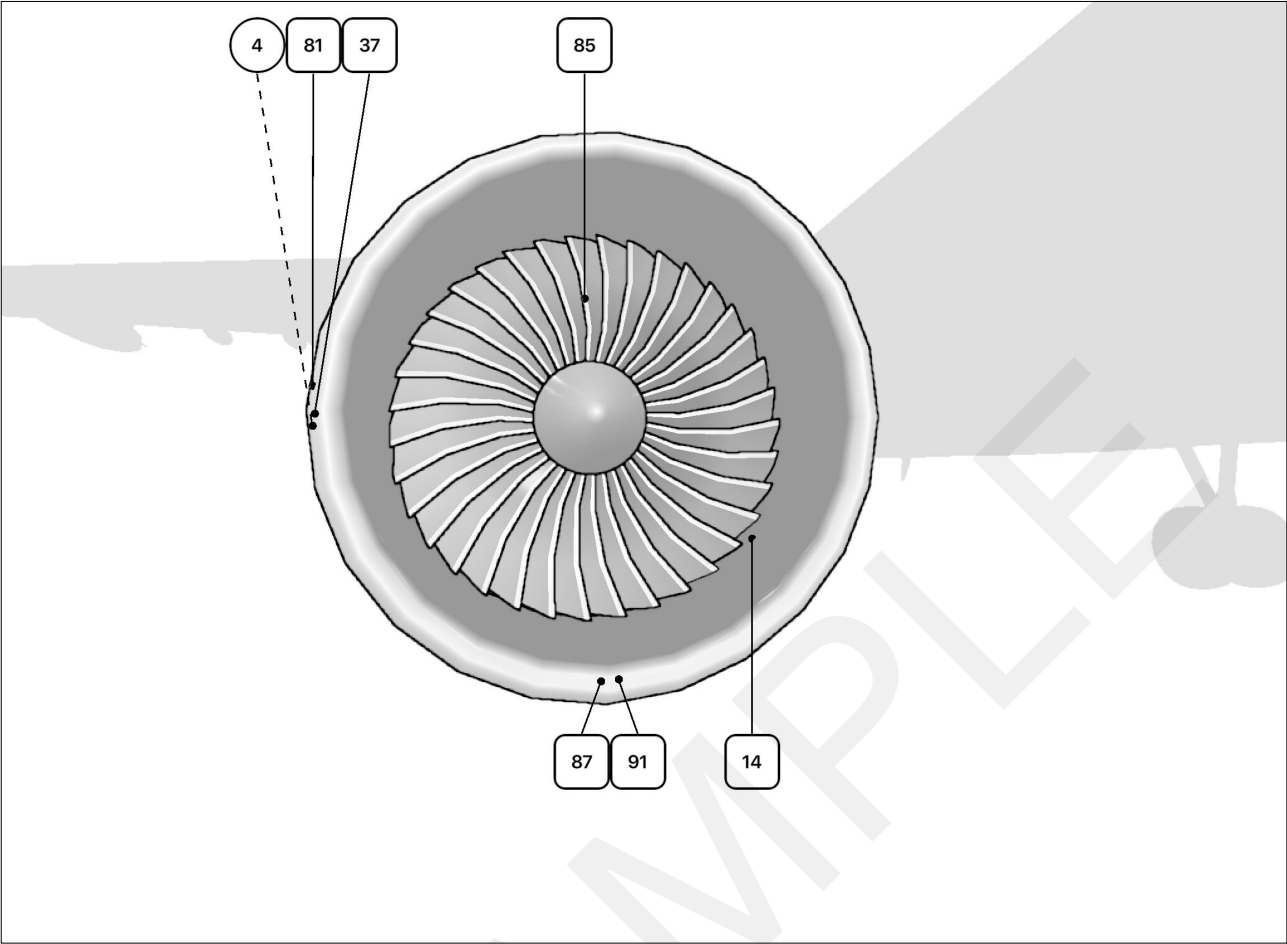
#2 Front

| No | Type | Location | Description | Date |
|---|---|---|---|---|
| 87 | Damage | COWL ASSY-AIR INLET - 1100KM2 | Scratch on COWL ASSY-AIR INLET - 1100KM2 | 29/11/2022 |
| 91 | Damage | COWL ASSY-AIR INLET - 1100KM2 | Scratch on COWL ASSY-AIR INLET - 1100KM2 | 03/12/2022 |

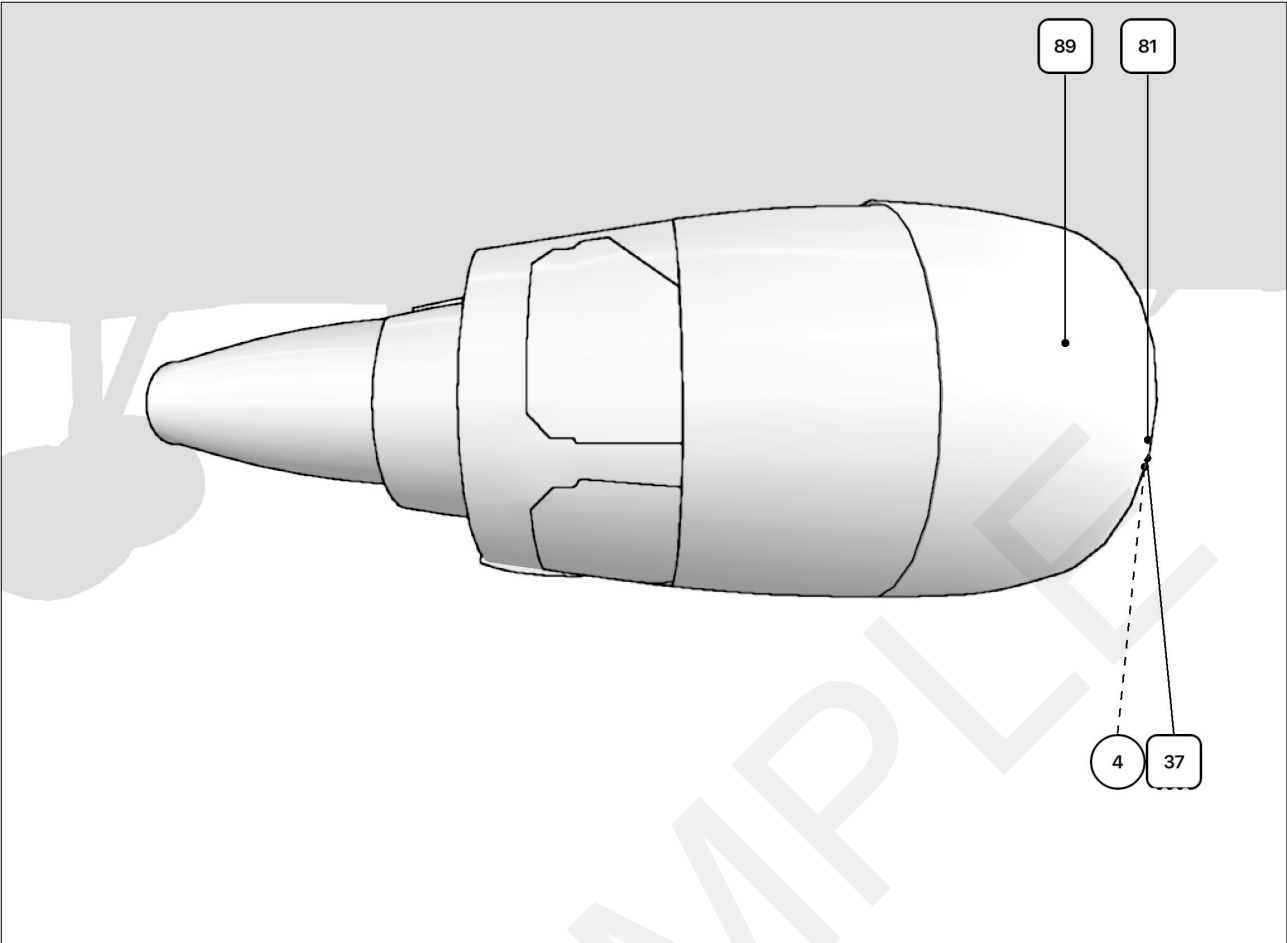
#2 RH Side

| No | Type | Location | Description | Date |
|---|---|---|---|---|
| 81 | Damage | COWL ASSY-AIR INLET - 1100KM2 | Dent on COWL ASSY-AIR INLET - 1100KM2 | 23/11/2022 |
| 89 | Damage | COWL ASSY-AIR INLET - 1100KM2 | Scratch on COWL ASSY-AIR INLET - 1100KM2 | 01/12/2022 |

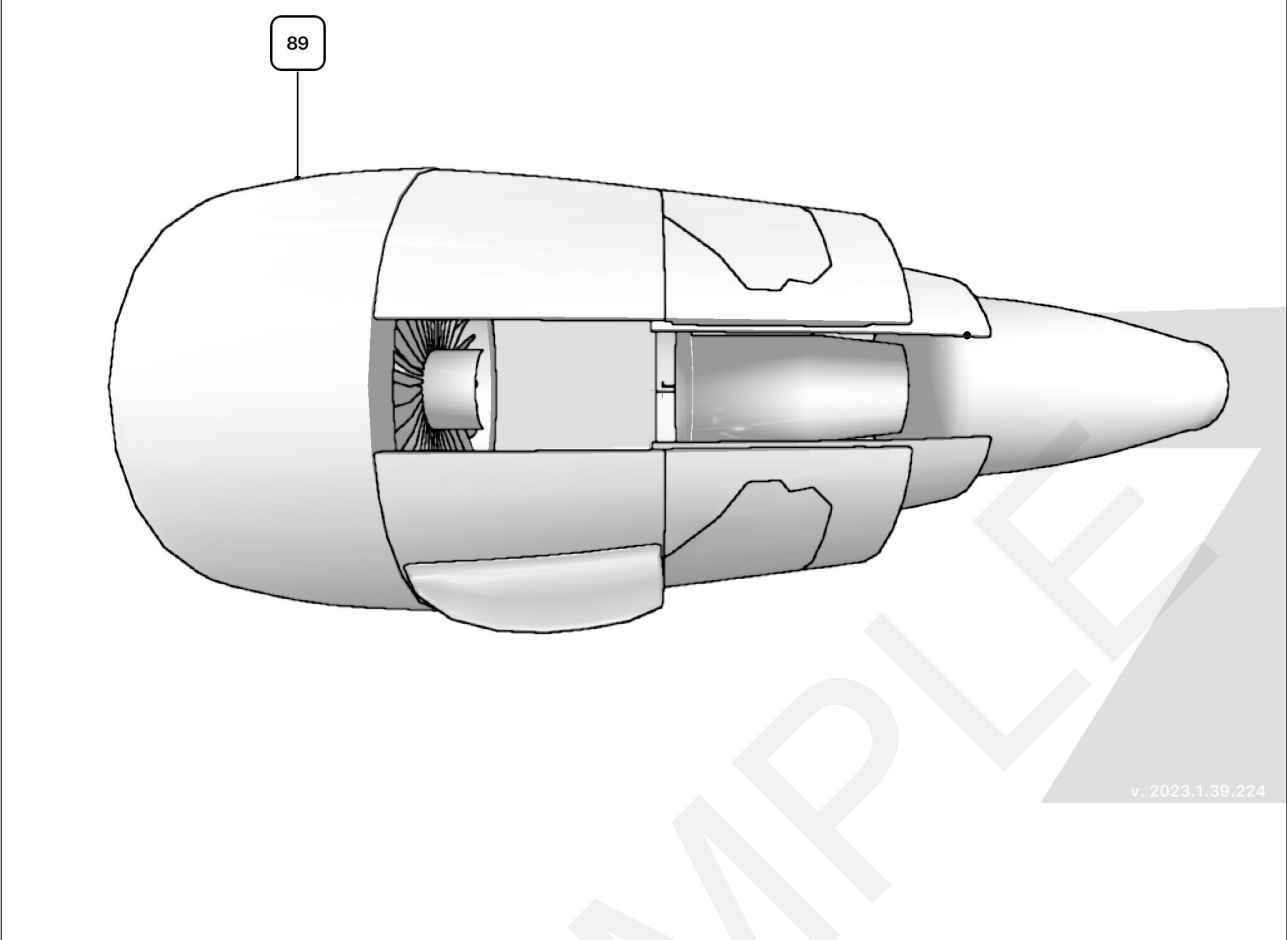
#2 Top

| No | Type | Location | Description | Date |
|---|---|---|---|---|
| 89 | Damage | COWL ASSY-AIR INLET - 1100KM2 | Scratch on COWL ASSY-AIR INLET - 1100KM2 | 01/12/2022 |

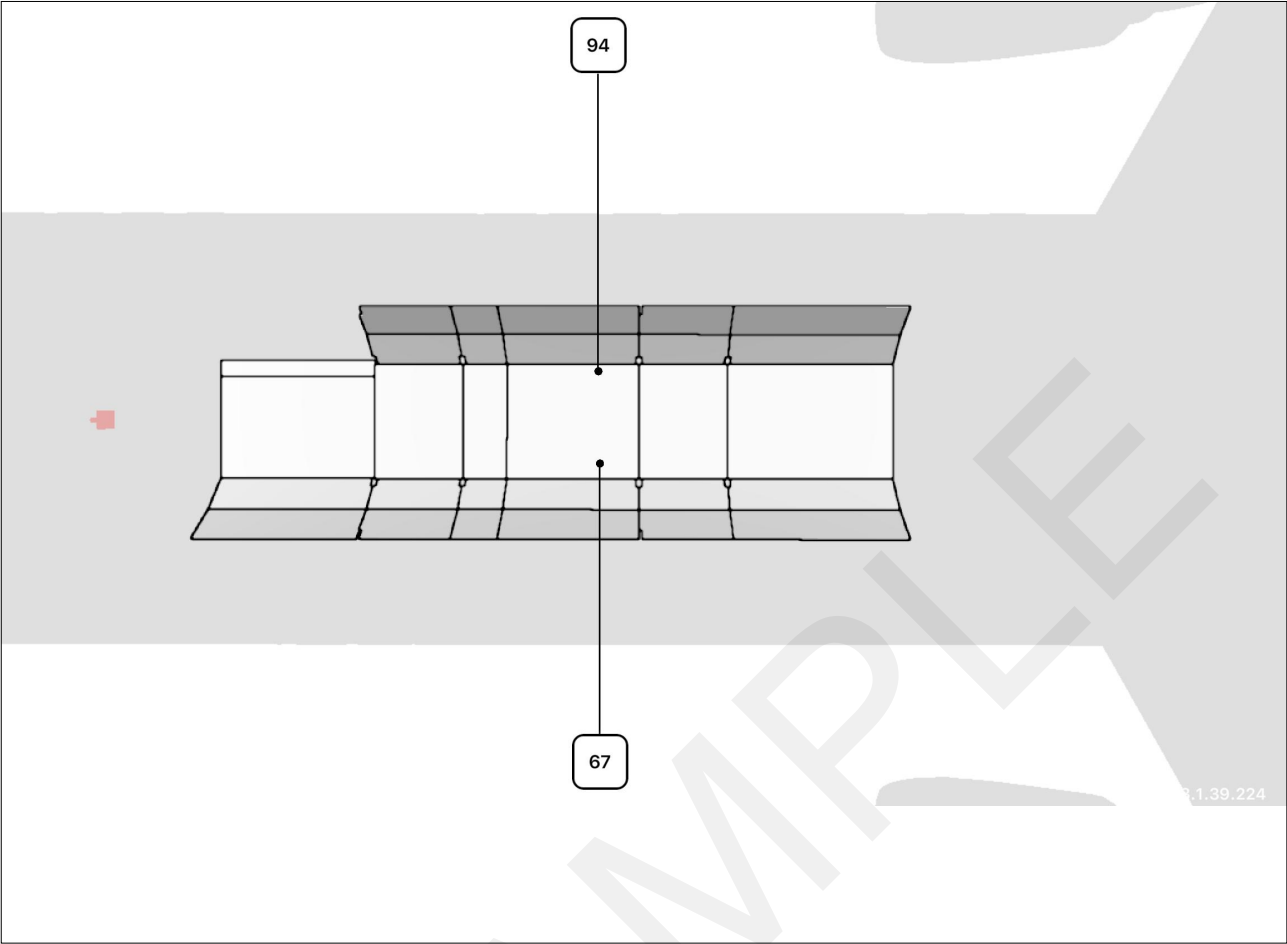
Fwd Cargo Floor

| No | Type | Location | Description | Date |
|---|---|---|---|---|
| 67 | Damage | FR33 + 50.00mm, STRG39LH + 10.00mm | Corrosion on Fuselage - Section 11/12 LH FR33 STRG39 | 09/11/2022 |
| 94 | Damage | FR33 + 50.00mm, STRG39RH + 10.00mm | Corrosion on Fuselage - Section 11/12 RH FR33 STRG39 | 06/12/2022 |

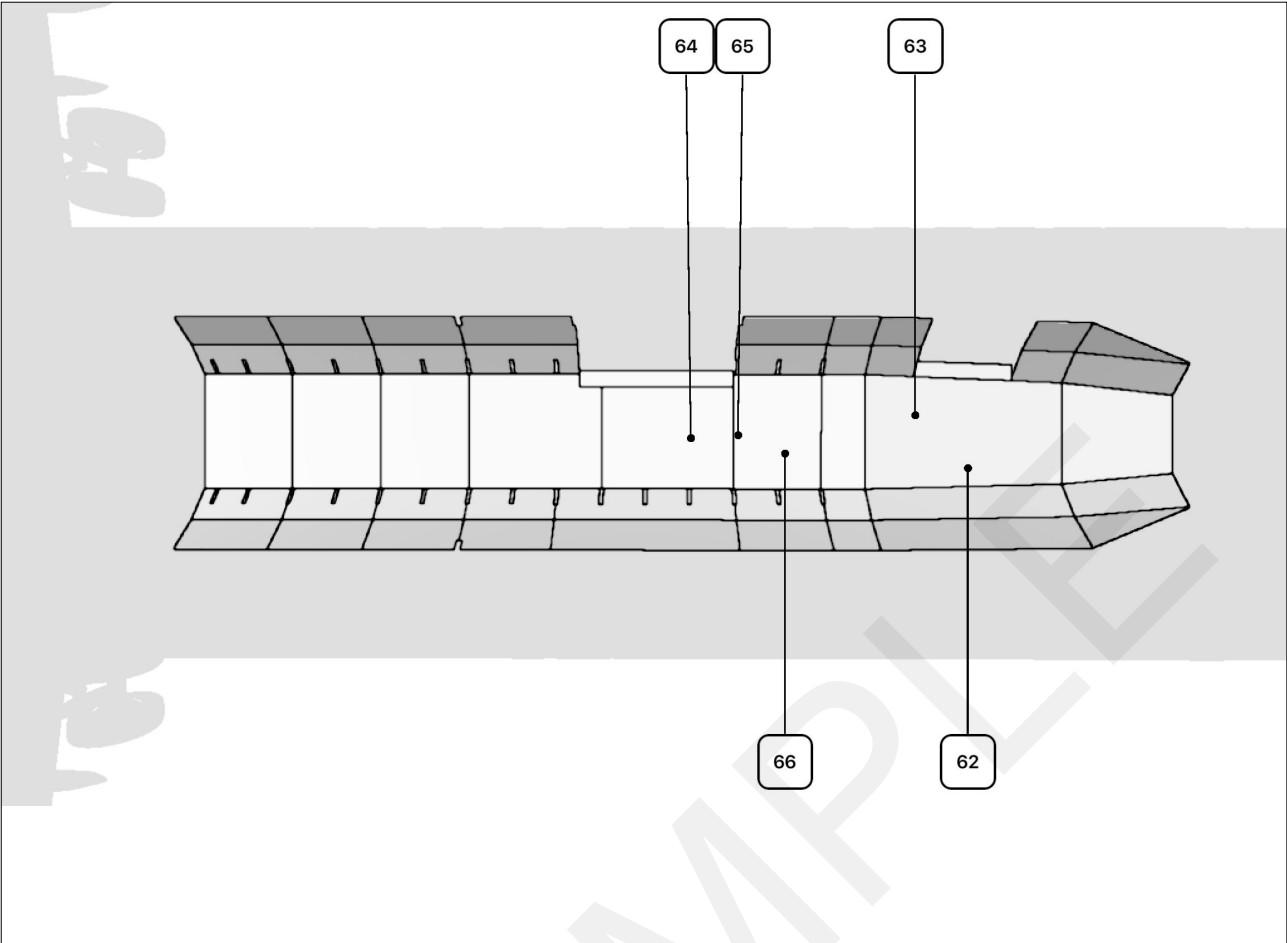
Aft Cargo Floor

| No | Type | Location | Description | Date |
|---|---|---|---|---|
| 65 | Damage | FR56 + 50.00mm, STRG44LH + 10.00mm | Corrosion on Fuselage - Section 11/12 LH FR56 STRG44 | 06/11/2022 |
| 66 | Damage | FR57 + 50.00mm, STRG42LH + 10.00mm | Corrosion on Fuselage - Section 11/12 LH FR57 STRG42 | 07/11/2022 |

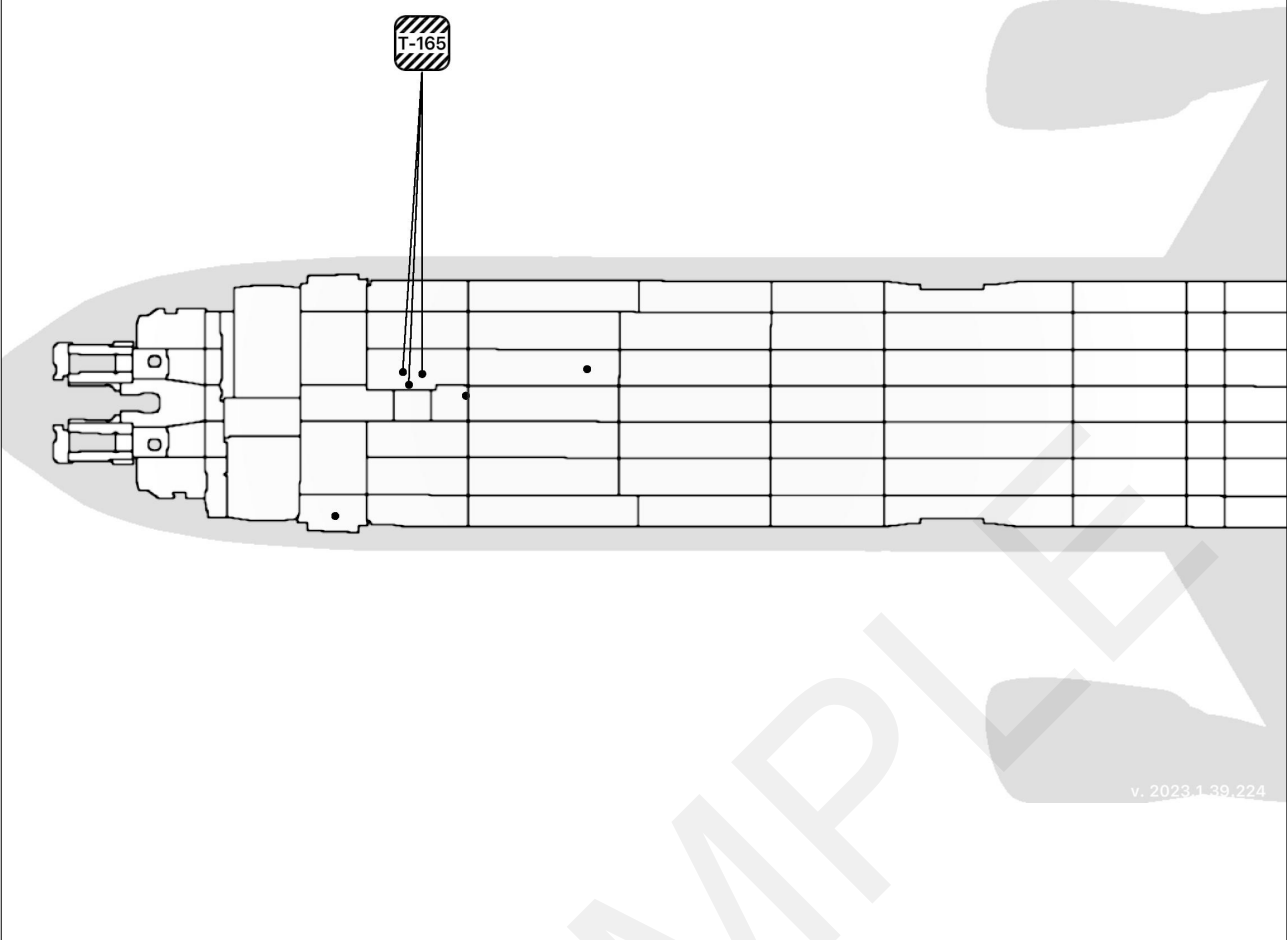
Fwd Cabin Floor

| No | Type | Location | Description | Date |
|---|---|---|---|---|
| T-165* | Damage | Passenger Floor Panel 39 | Corrosion | 23/10/2024 |

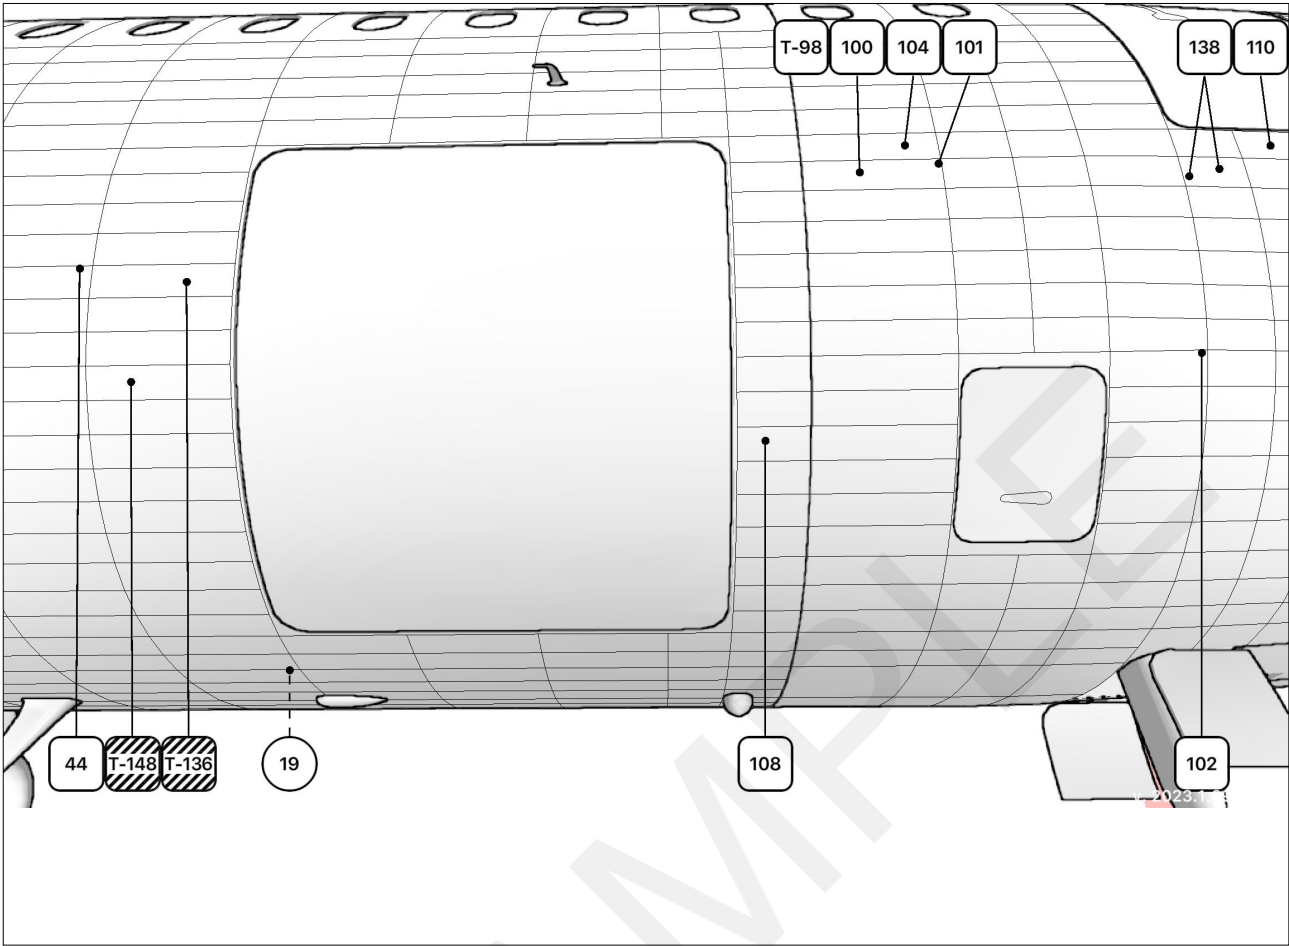
| No | Type | Location | Description | Date |
|---|---|---|---|---|
| T-98* | Damage | FR23 + 280.00mm, STRG18RH + 55.00mm | Dent - Fuse Skin, AFT of R1 Door, FWD of Triangle Reference Point, FR 23 -24, S18R-S19R | 26/09/2023 |
| 110 | Damage | FR18 + 98.00mm, STRG23RH + 66.00mm | Dent | 07/02/2024 |
| 138 | Damage | FR19 + 100.00mm, STRG24RH + 50.00mm | Lightning strike | 05/06/2024 |

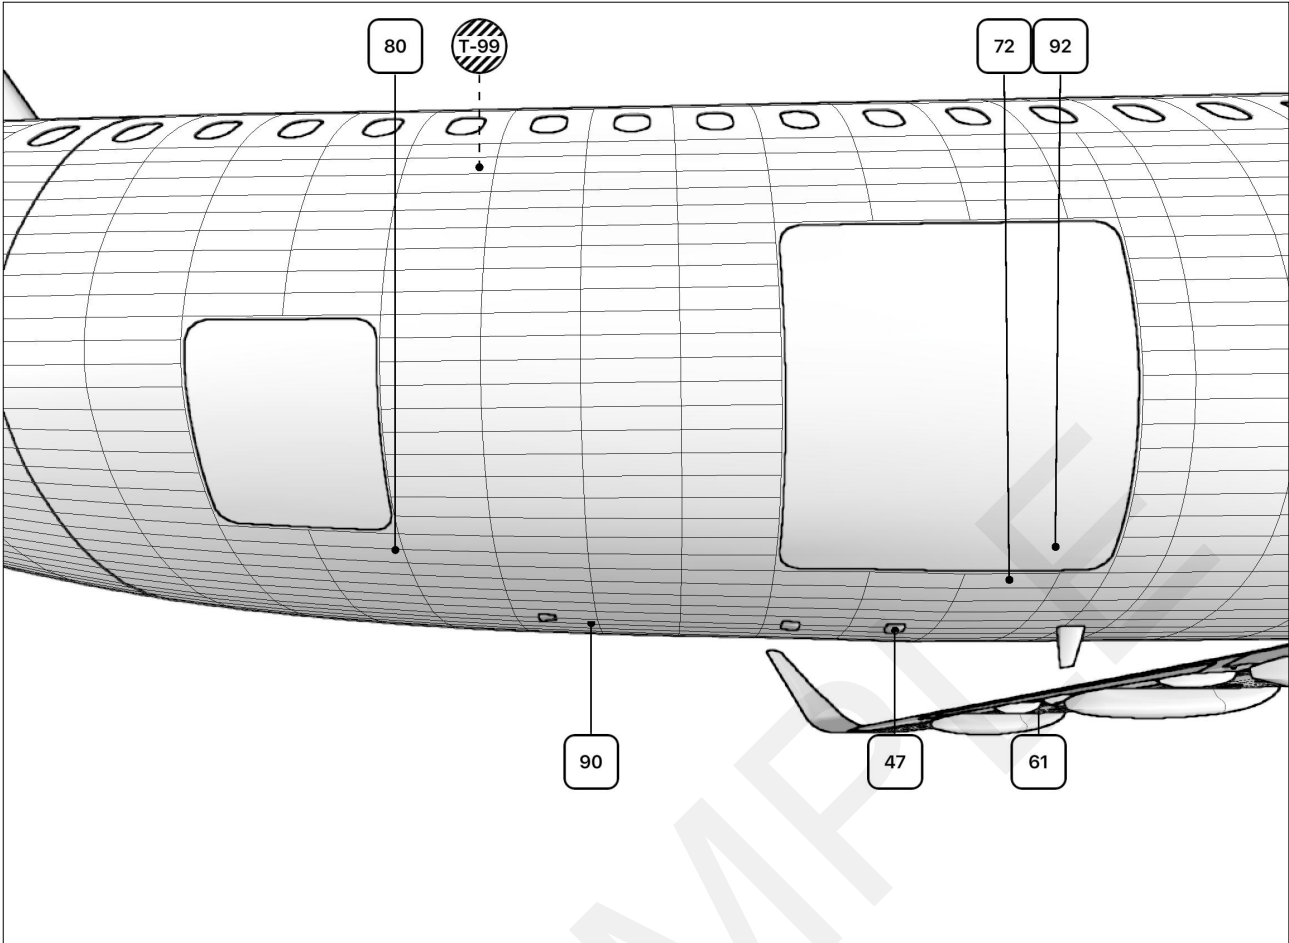
| No | Type | Location | Description | Date |
|---|---|---|---|---|
| T-99* | Repair | FR59 + 94.00mm, STRG19RH + 93.00mm | Dent - Fuse. Skin, FR59, S19R-S20R | 26/09/2023 |
