## DAMAGE CHART

A/C Reg: T-A321C

Type: A321i

Effective date: 04-Jun-2025 / 07:21 UTC

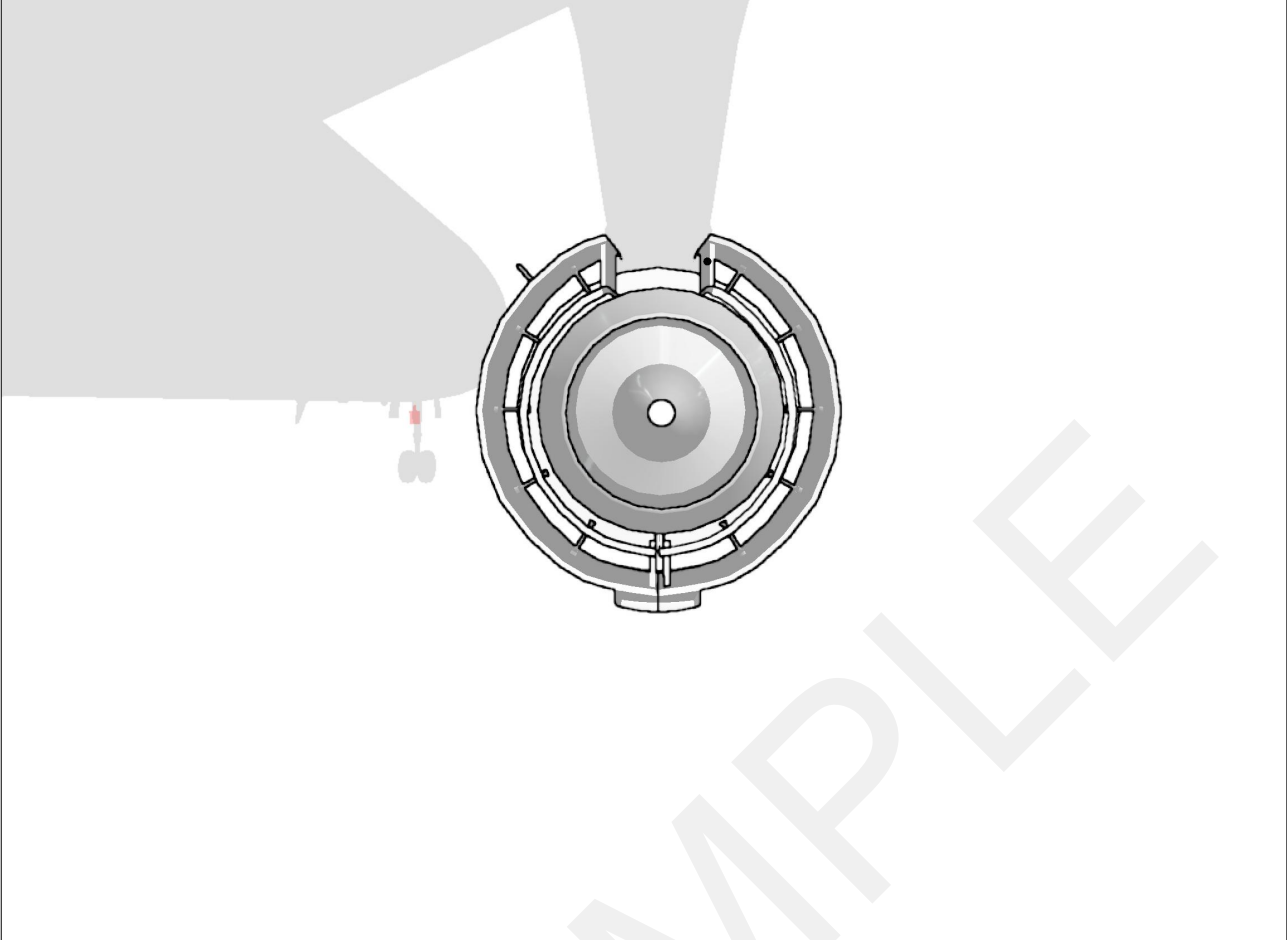
#2 Rear

| No | Type | Location | Description | Date |
|---|---|---|---|---|
| 87 | Damage | COWL ASSY-AIR INLET - 1100KM2 | Scratch on COWL ASSY-AIR INLET - 1100KM2 | 29/11/2022 |
| 91 | Damage | COWL ASSY-AIR INLET - 1100KM2 | Scratch on COWL ASSY-AIR INLET - 1100KM2 | 03/12/2022 |

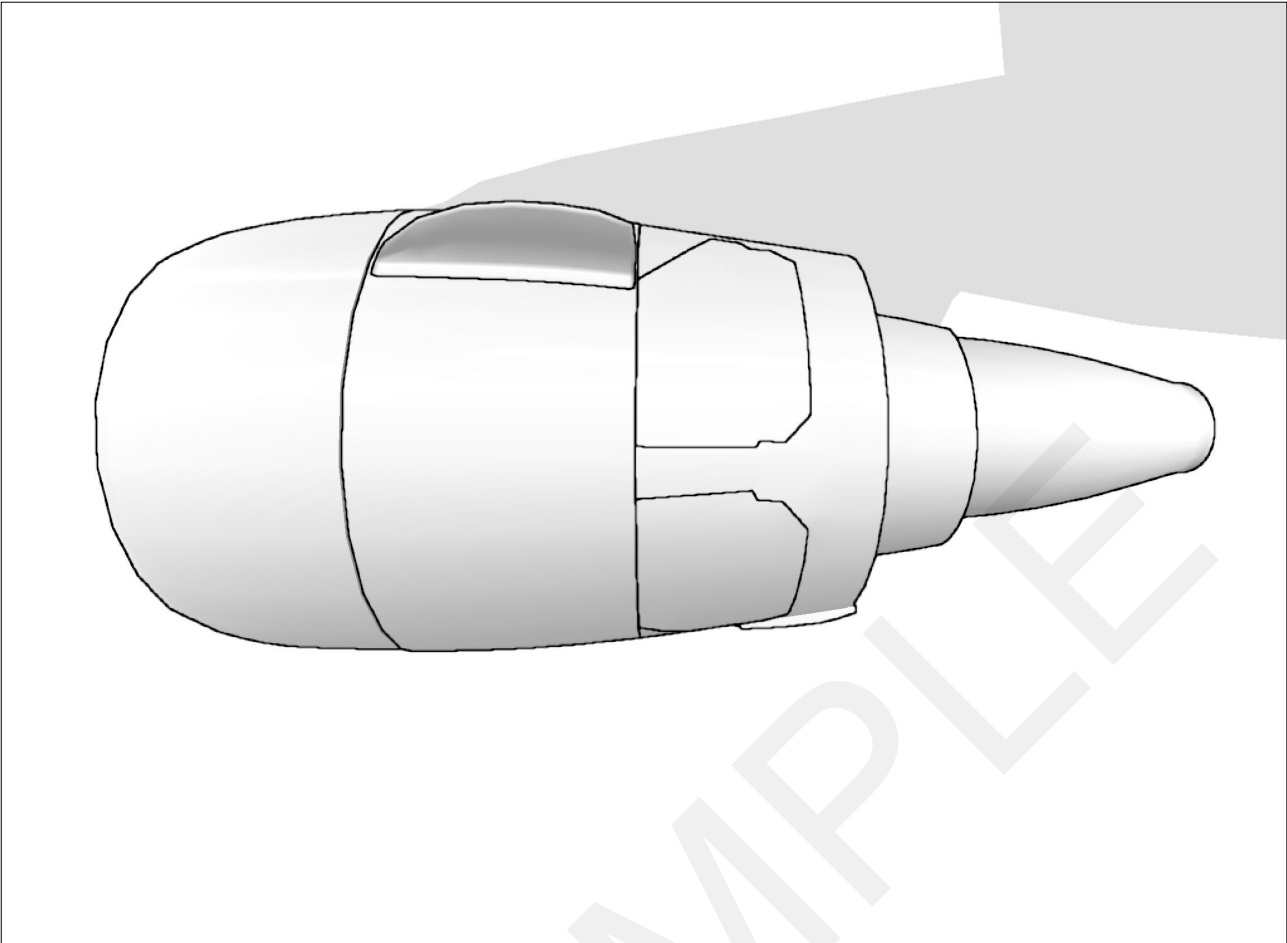
#2 LH Side

| No | Type | Location | Description | Date |
|---|---|---|---|---|
| 81 | Damage | COWL ASSY-AIR INLET - 1100KM2 | Dent on COWL ASSY-AIR INLET - 1100KM2 | 23/11/2022 |
| 89 | Damage | COWL ASSY-AIR INLET - 1100KM2 | Scratch on COWL ASSY-AIR INLET - 1100KM2 | 01/12/2022 |

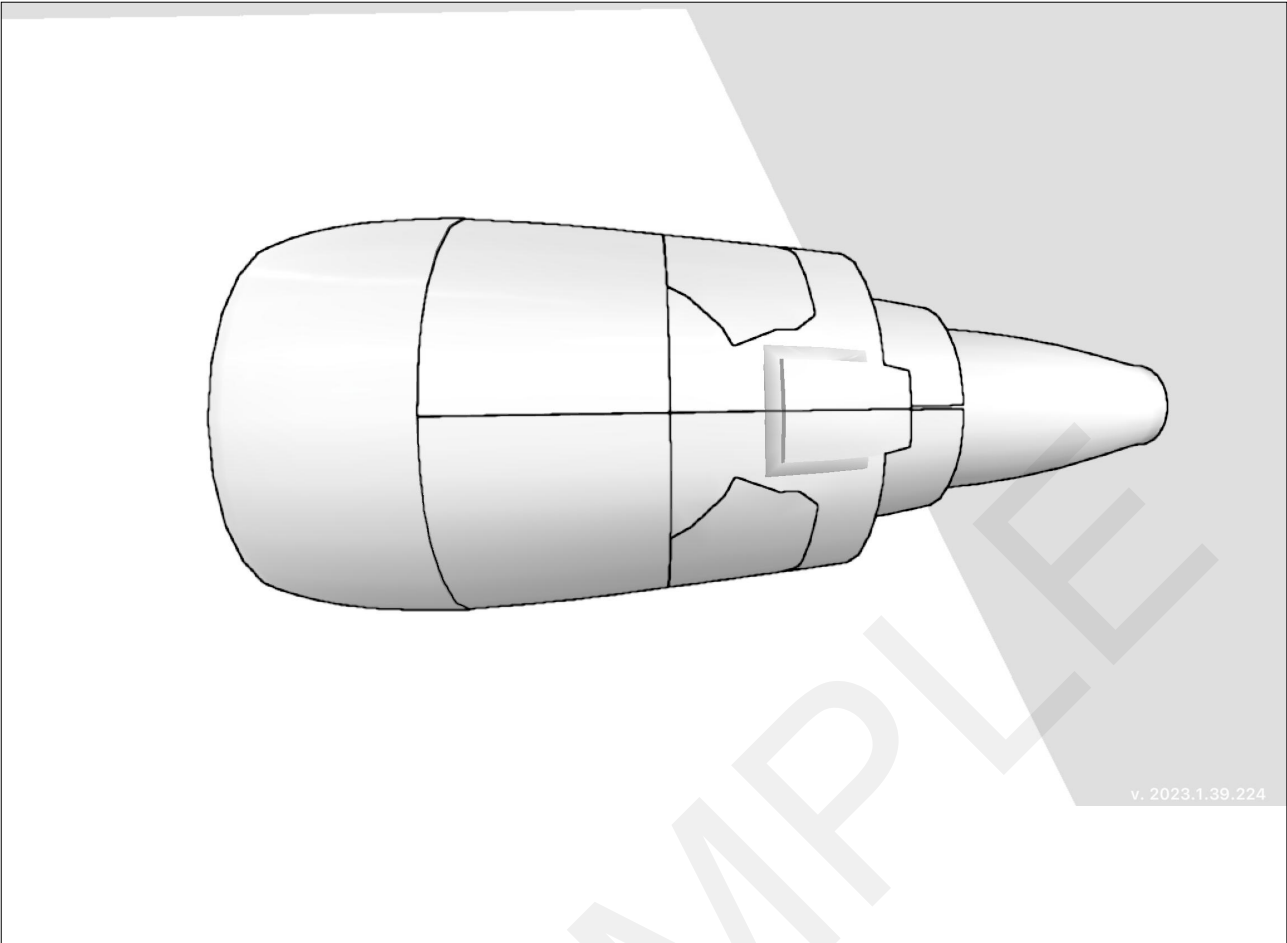
#2 Lower

| No | Type | Location | Description | Date |
|---|---|---|---|---|
| 89 | Damage | COWL ASSY-AIR INLET - 1100KM2 | Scratch on COWL ASSY-AIR INLET - 1100KM2 | 01/12/2022 |

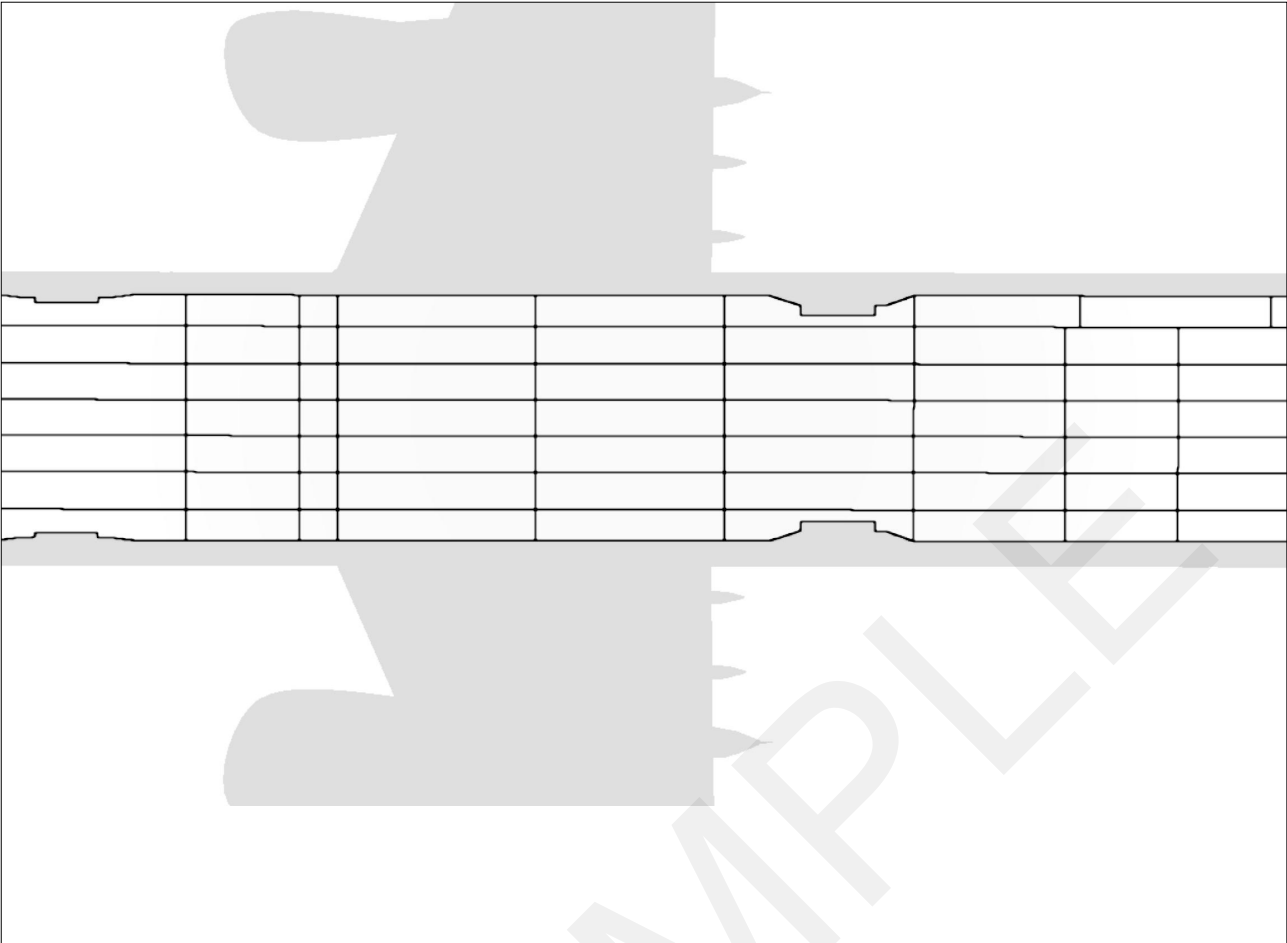
Centre Cabin Floor

| No | Type | Location | Description | Date |
|---|---|---|---|---|
| T-165* | Damage | Passenger Floor Panel 39 | Corrosion | 23/10/2024 |
